Test Report - Commercial in Confidence W0017 IWA14-1 2013 N3 Rapid Deployment Barrier

Test Laboratory HORIBA MIRA Ltd
Date of Report 24/04/2019
Client GDTech S.A
Test Item F18 Steel rapid deployment system
Date of Test 26/02/2019
Test Number W0017
Report Number IWA14-1 1219545-002-01
Test Type Vehicle Impact
Product Rating IWA 14-1:2013 Barrier V/7200[N3C]/48/90:29.1
Number of Pages 21

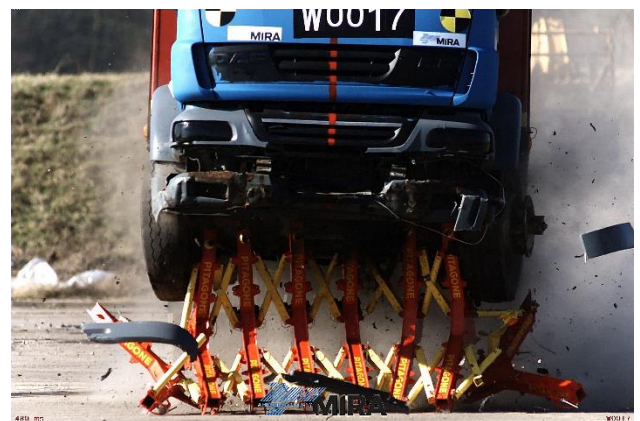
The test vehicle centreline was aligned to the middle of the deployed units. Upon impact the units rotated forward with the rear lower spikes digging into the ground and the units coming into contact with the underside of the vehicle and engine. The front axle lifted off the ground and the units were pushed forward. As the units were pushed they became separated and rotated. The vehicle dropped back down onto the units which then came into contact with the prop shaft causing more damage to the test item and lifting the rear axle from the floor. The vehicle then slowed coming to a halt with 29.1m of penetration.

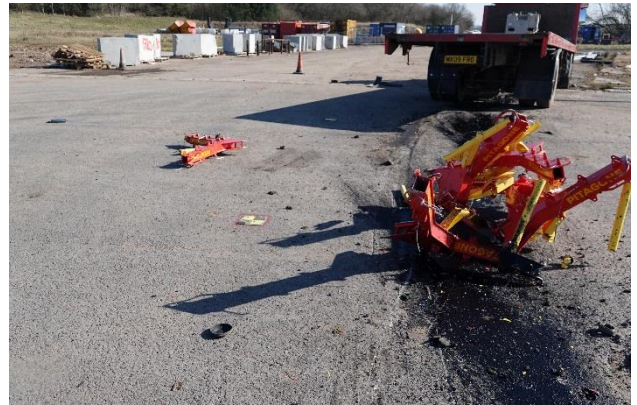
2 units remained trapped under the vehicle, 5 units were attached together 16m into the incident with the link bars twisted and some torn through the drilled pinning points. 1 unit was at 19m forward and 2.5 m to the left of target impact point. All of the units had suffered damage from the impact to varying degrees including all the positioning wheels which were all damaged, rear ground hooks were bent and powder coating damage with some twisting of the main structures.

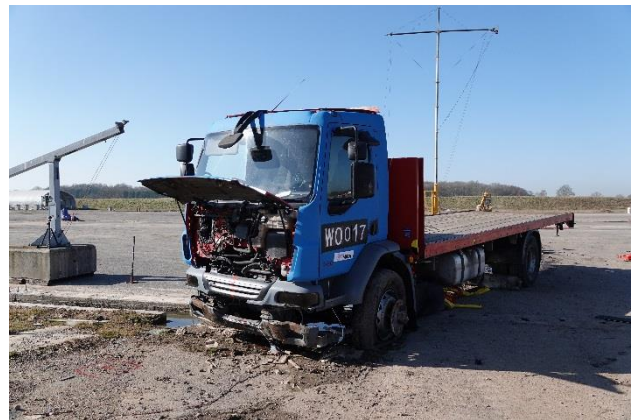
The front cosmetic panels suffered damage. As did the front bumper. Front driver side tyre was cut. The engine sump was torn open allowing engine oil to be distributed along the floor. The engine was still running and allowed for a follow on attempt which failed due to the 2 units underneath becoming entangled and causing the wheels to loose traction. The centre and rear prop shaft bearings were also damaged along with marking on the prop shaft itself. The Ad-Blue tank was torn from its mountings and the rear exhaust silencer was detached.
