## Test Report - Commercial in Confidence W0017 PAS68 N3 Rapid Deployment Barrier

Test Laboratory	HORIBA MIRA Ltd
Date of Report	24/04/2019
Client	GD Tech S.A
Test Item	F18 Steel rapid deployment system
Date of Test	26/02/2019
Test Number	W0017
Report Number	PAS68 1219545-002-02
Test Type	Vehicle Impact
Product Rating	PAS68:2013 Barrier V/7500(N3)/48/90:28.1/18.0
Number of Pages	20

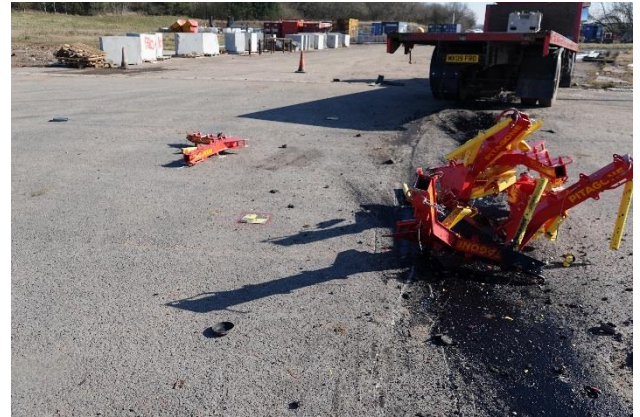
2 units remained trapped under the vehicle, 5 units were attached together 16m into the incident with the link bars twisted and some torn through the drilled pinning points. 1 unit was at 18m forward and 2.5 m to the left of target impact point. All of the units had suffered damage from the impact to varying degrees including all the positioning wheels which were all damaged, rear ground hooks were bent and powder coating damage with some twisting of the main structures.

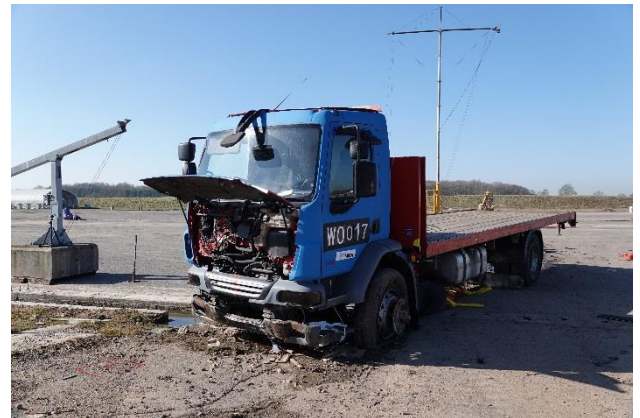
The front cosmetic panels suffered damage. As did the front bumper. Front driver side tyre was cut. The engine sump was torn open allowing engine oil to be distributed along the floor. The engine was still running and allowed for a follow on attempt which failed due to the 2 units underneath becoming entangled and causing the wheels to loose traction. The centre and rear prop shaft bearings were also damaged along with marking on the prop shaft itself. The Ad-Blue tank was torn from its mountings and the rear exhaust silencer was detached.
