# CABLE CATCHER

## Cable Catcher System

As per ASTM Standard:

F 1642-04/GSA TS01 - level 3A

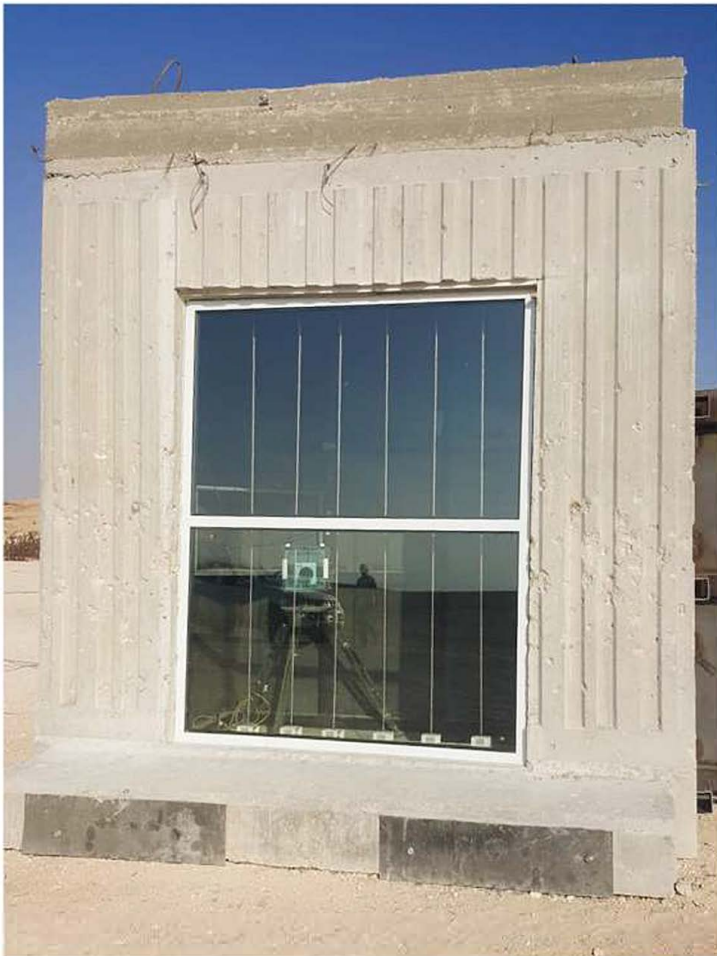
The G.G. retrofit cable system can catch the window as it moves inward under the blast effect and prevent glass fragments and window frame debris from flying into the building.

The G.G. retrofit cable system is composed of steel cables with special energy absorbing modules at the top and bottom, anchored into the ceiling and floor.

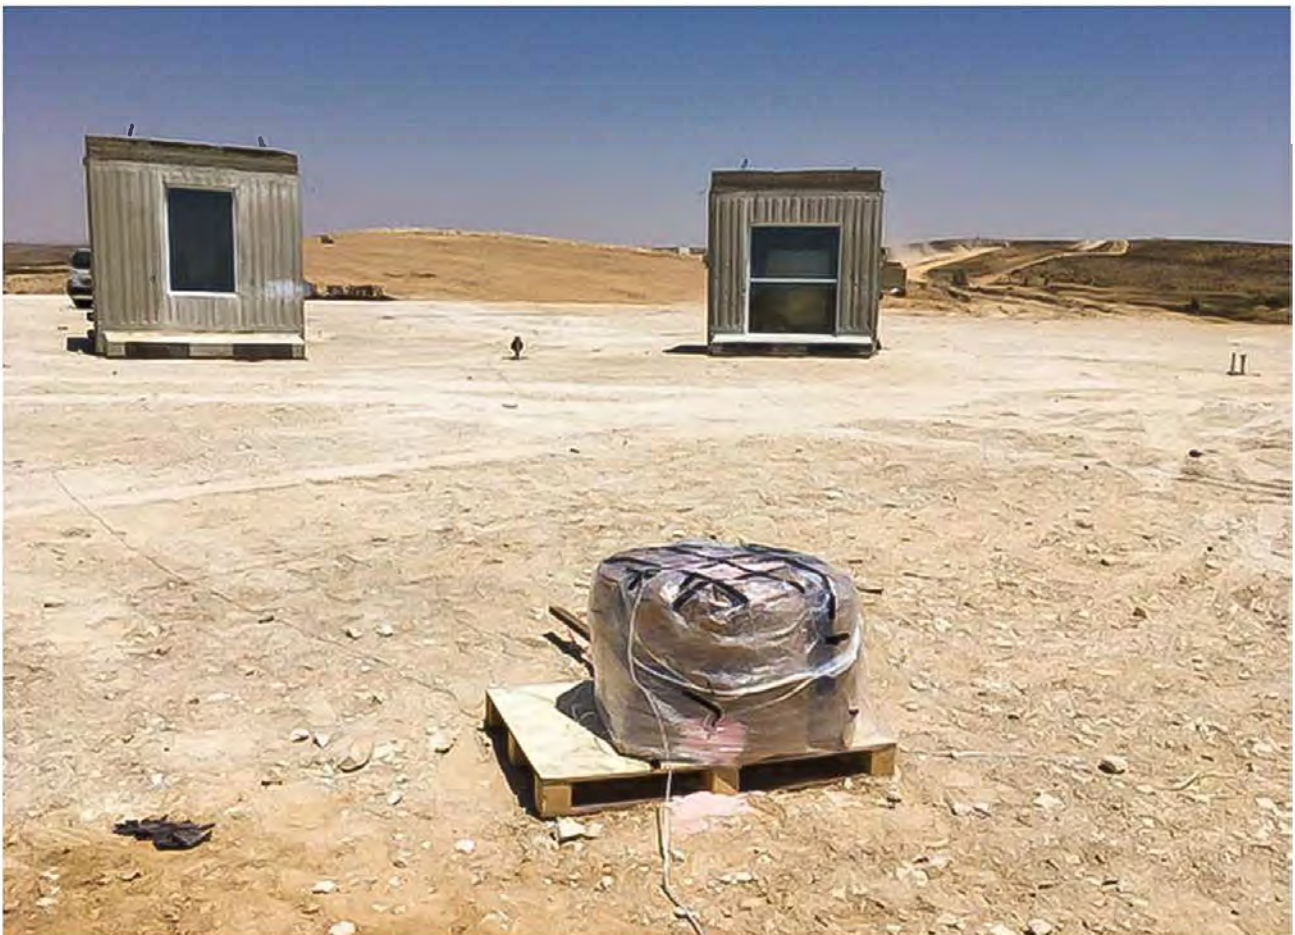
Two concrete walls were installed at a certain distance from an explosive charge of 400 kg Ammonium Nitrate and fuel oil (ANFO).

Two window sizes were tested:  
1000mm X 1700mm fixed window and 1000mm X 1620mm curtain wall  
with 4 and 6 cables (respectively) connected to the concrete with energy  
absorbing modules to catch the windows.

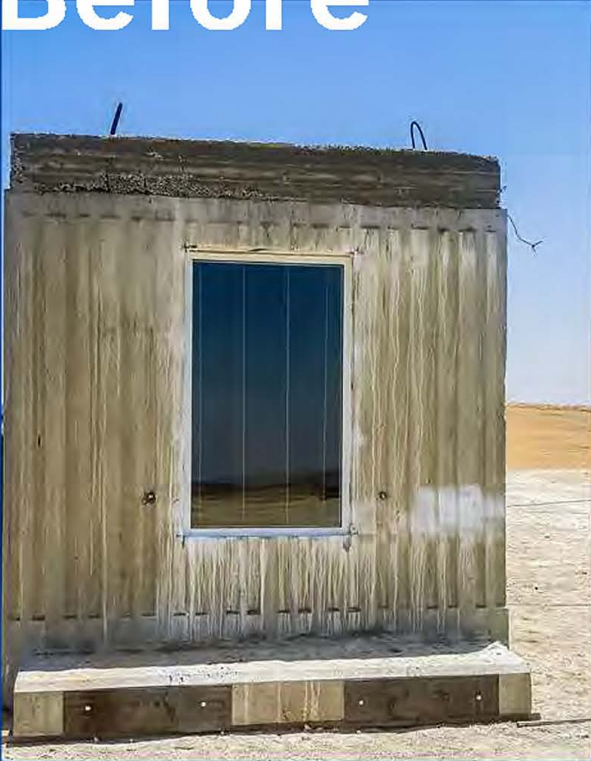
## Before

# Cable Catcher: Blast Test, First Wall: Fixed Window

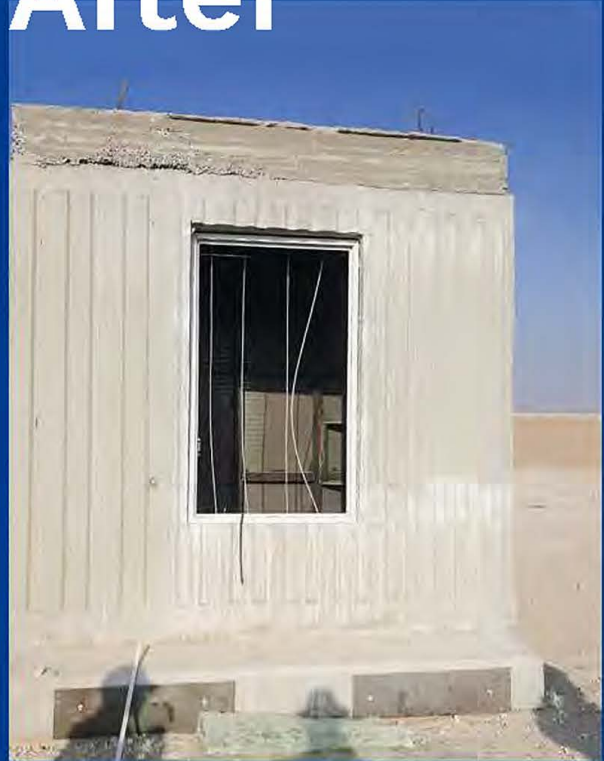
## After

- The glazing and debris of the window frame were found in front of the target, while the cables were tensed and remained bent with a maximum inward deflection in the middle of about 35cm.
- The energy absorbing modules were elongated by controlled elastic deformation at the bottom.
- No damage was observed in any anchors, all which remained in place.
- Small glass fragments were found on the floor up to 1 meter

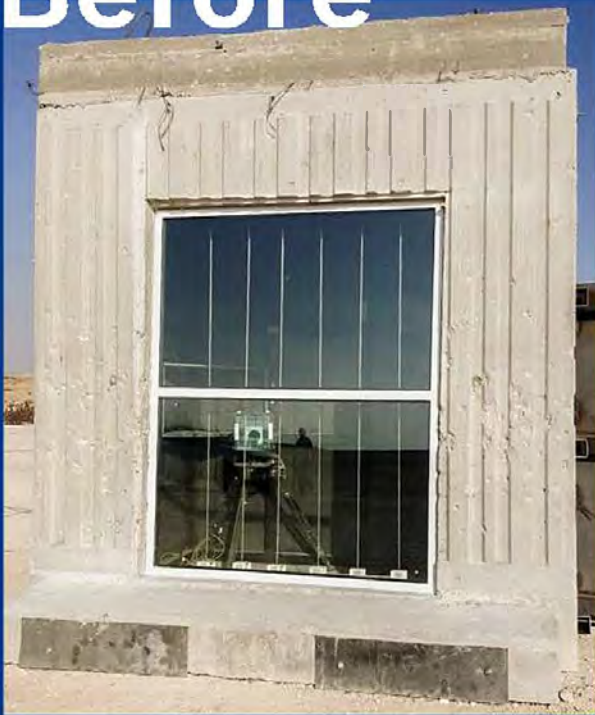
## Before

# Cable Catcher: Blast Test, Second Wall: Curtain Wall

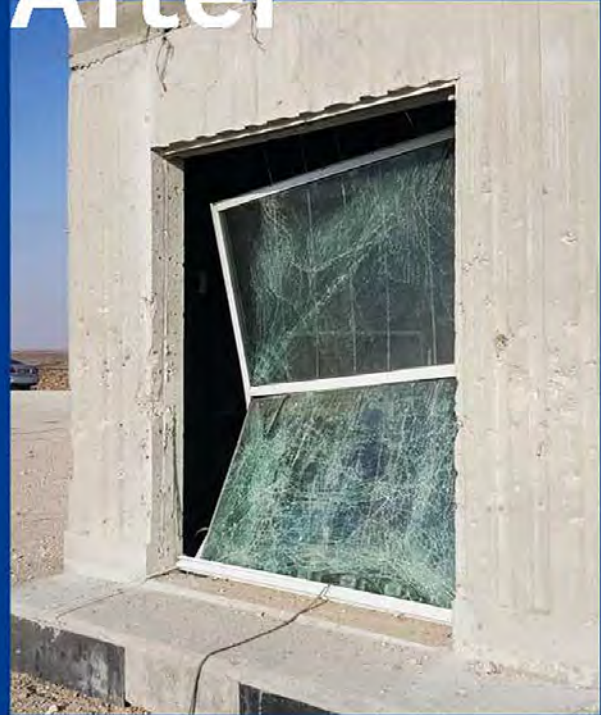
## After

- The window and its distorted frame were found "caught" on the cables which were tensed and remained bent with a maximum inward deflection in the middle of about 45cm.
- The glazing cracked but remained in the frame.
- The energy absorbing modules were elongated by controlled elastic deformation and no damage was observed in any of the anchors, all which remained in place.
- Small glass fragments were found on the floor just behind the window (up to 1 m)
