GROUND RETRACTABLE AUTOMOBILE BARRIER GRAB®-400

Report No.: 400001-USR21
Report Date: January 2011

ASTM F2656-07 TEST M40 OF THE 12 FT GRAB-400

Contract No. P2011039
Test No. 400001-USR21
Test Date: November 11, 2010

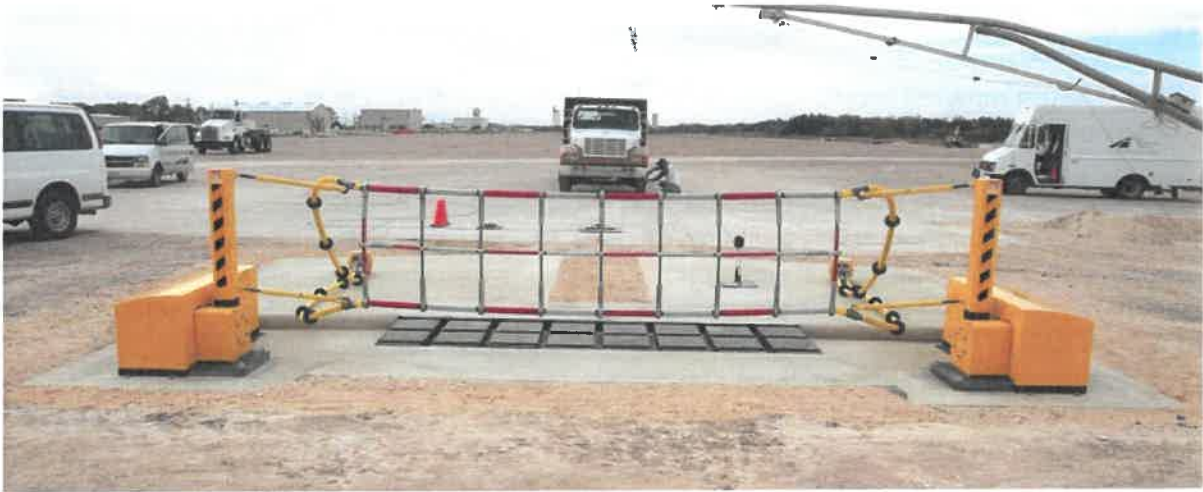
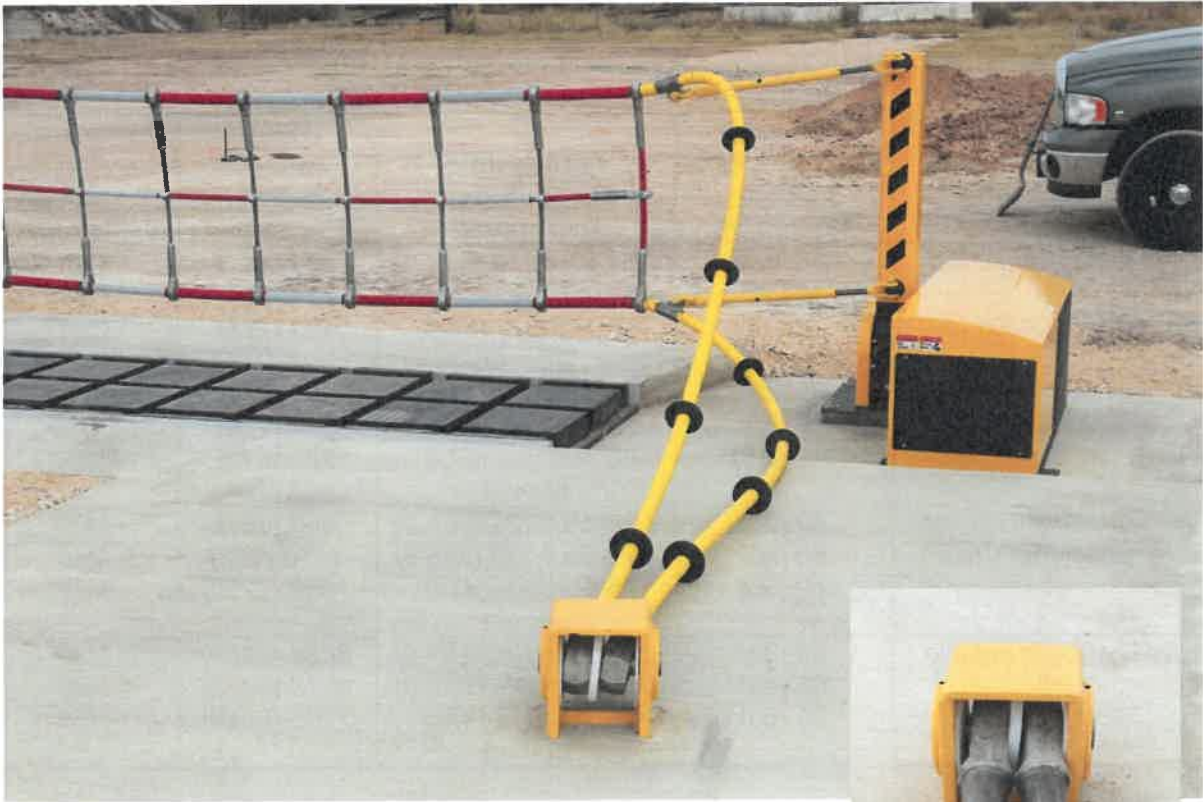
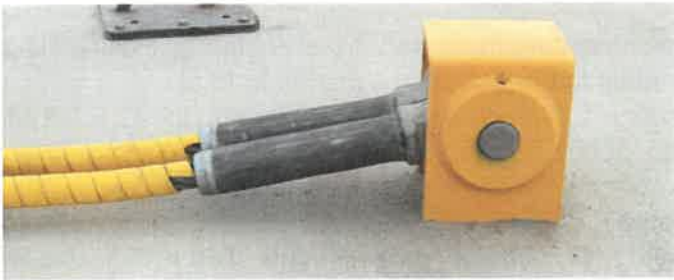
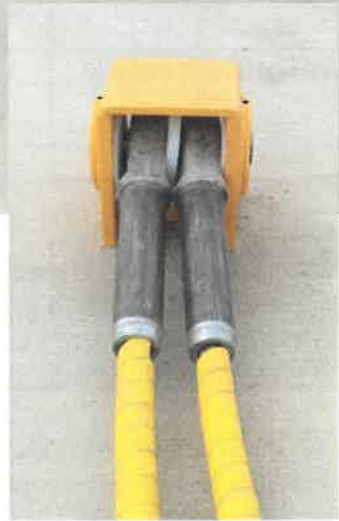
Figure 2. 12 ft GRAB-400 prior to testing.

An 18-inch concrete apron was constructed between the anchor stanchion's concrete foundations. The concrete apron was approximately 27 ft 6 inches long by 6 ft 9¾ inches wide and provides a 12-ft barrier lane width between the net lift arms for vehicular travel. In addition, the concrete apron was used as a foundation for the lift arm assemblies. Embedded in the apron is a 24-inch wide net pad that protects the net from vehicle travel when in the non active position. The concrete apron was poured integrally with the anchor stanchion foundations. Reinforcing steel was used to connect the two foundation systems. Reinforcement in the apron consisted of #5 reinforcing steel spaced at 12 inches on center, each way. One single mat of reinforcing steel was used to construct the apron. All reinforcing steel was ASTM A615 Grade 60 material. The compressive strength of the apron concrete was specified to be 4000 psi, and on the day the test was performed it was 4587 psi. Details of the system are provided in figure 1, and photographs of the completed installation are shown in figure 2.

Universal Safety Response, Inc. (USR) GRAB-400 12 ft active vehicle barrier is a deployable gate/net system. The vehicle barrier tested herein consists of a net, anchor stanchions and proprietary lift arm mechanism. The width of the net for this test was 12 ft. The net was anchored on each end by a separate anchor stanchion and foundation. The net has upper and lower horizontal 1-½-inch diameter wire ropes with closed swage end connections. Vertical ¾-inch diameter wire ropes are attached to the main horizontal wire ropes and the middle horizontal ¾-inch diameter wire rope.

The net is deployed by an electric motor attached to a secondary post system located on each end of the net. The posts in the lifting arm assembly were HSS10×6×¾. The net is attached to these secondary posts by a 5/16-inch shear pin and turnbuckle assembly that allow for tensioning of the net between deployment posts. Details of the net system are shown in figure 1.

Swage fittings connect the net to the stanchion anchors at each end. A 2¼-inch × 11-inch pin connecting the swage fittings to the stanchion anchors. The pin is fabricated from ASTM 416 stainless steel material. A ¼-inch thick plastic washer was used between the swage fitting and the stanchion anchors. A ¾-inch thick plastic washer was used to separate the two swage fittings. Details of the pipe sleeves are provided in figure 1.

A steel anchor stanchion assembly was used to anchor the stanchion sleeves to a concrete foundation. For this test, the distance between the stanchion centerlines was approximately 18 ft 6 inches. The steel anchor stanchion assembly consisted of a W8×67 structural steel section welded to a TS20×8×½ structural steel tube. The W-section was manufactured from ASTM A992 steel material. The structural tube was manufactured from ASTM A500 Grade B material. The TS20×8×½ steel tube was 90 inches long. Four square holes were machined into the steel tube; the tube was filled with concrete while pouring the foundation. The W-section was 25 inches long and welded perpendicular to the tube section such that 14½ inches were above the top of the tube section. The top 8.3 inches of the W-section's web was removed to receive a stanchion pin. A ½-inch plate was welded across the top of the w-section. The flanges of the W-section were reinforced by welding a 6¾-inch diameter by ¾-inch thick steel plate. A 2.3-inch diameter hole was drilled through the W-section and reinforcing plates to receive the stanchion pin. All steel plates were manufactured from ASTM A36 material. Details of the steel anchor stanchion assembly are provided in figure 1.

Each anchor stanchion assembly was anchored to an irregularly shaped concrete foundation, as shown in figure 1. The concrete foundation was 18 inches deep. Reinforcement in the foundation consisted of #5 reinforcing steel at 1 ft typical spacing in two mats of reinforcing steel (top and bottom) with the exception of the longitudinal reinforcing immediately beneath the steel anchor stanchion. Addition assemblies of prebent #5 reinforcing bars, 6 inches on center, were used around the steel anchor stanchions. These bars helped to anchor the steel anchor stanchion in the concrete foundation. All reinforcing steel was ASTM A615 Grade 60 material. Considering the deployed state of the net from the impact of the vehicle, the foundations and steel anchor stanchion assemblies were oriented 15 degrees from the direction of travel of the vehicle. The compressive strength of the foundation concrete was specified to be 4000psi, and on the day the test was performed it was 4587 psi.

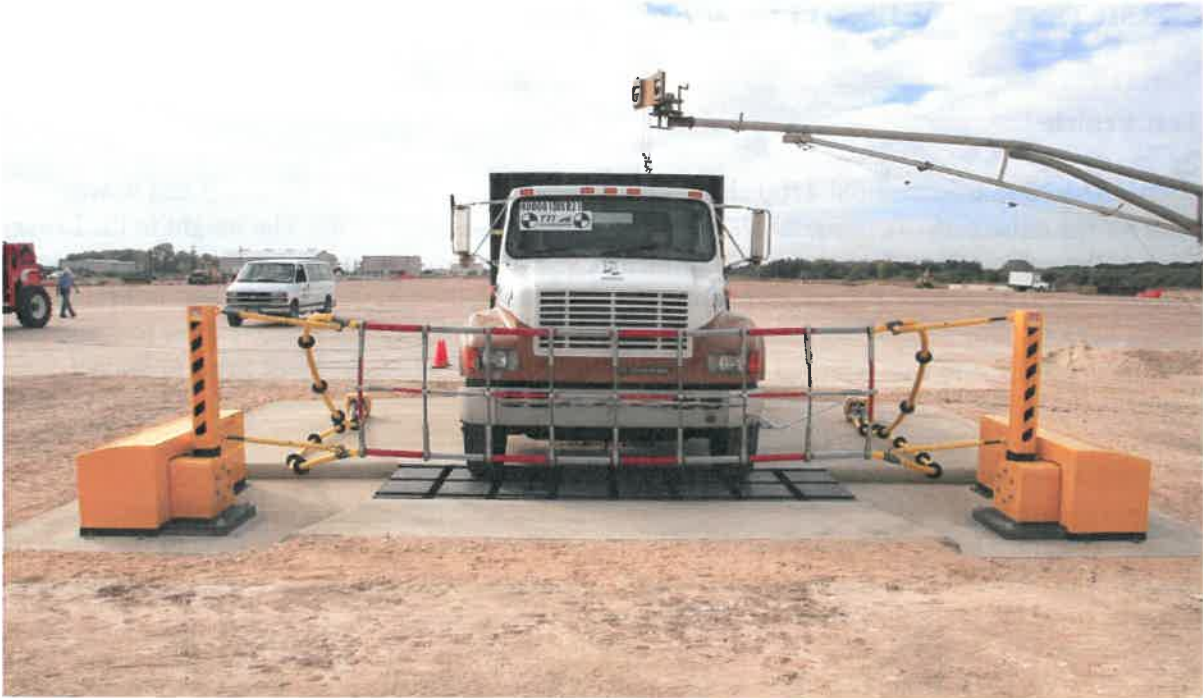
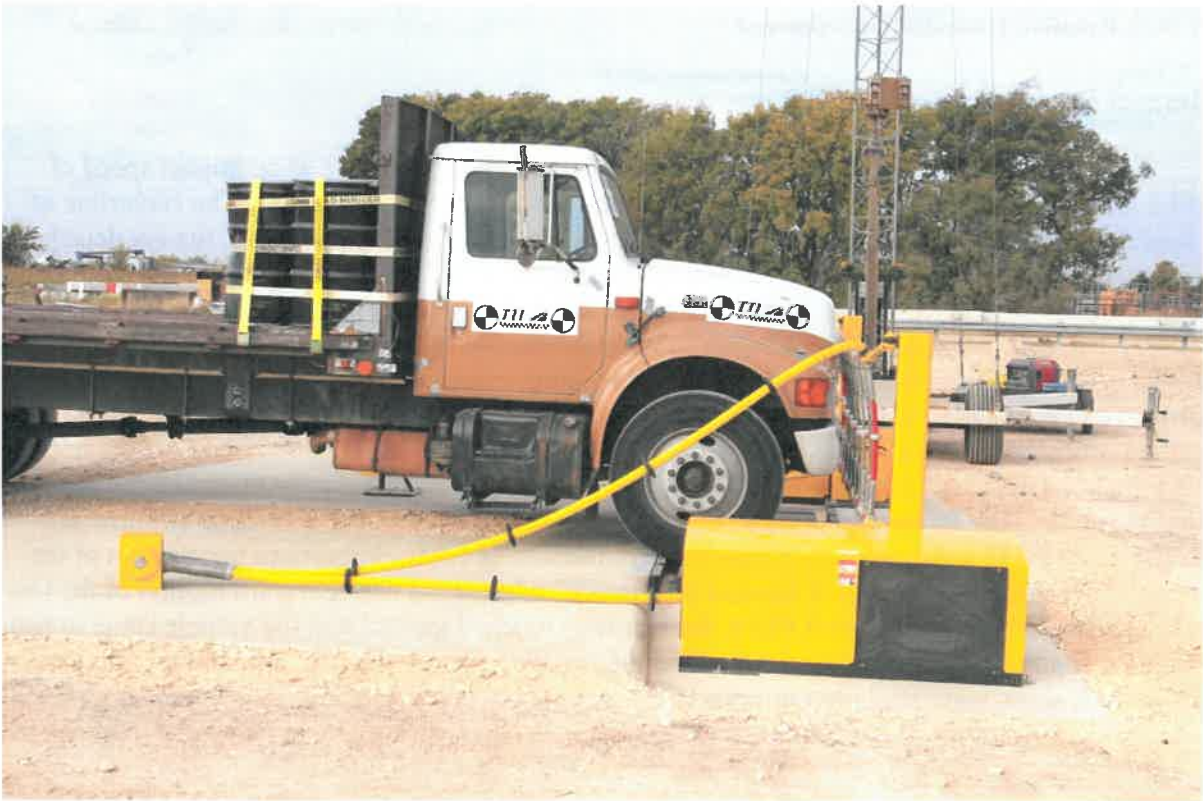
Figure 3. Vehicle/installation geometrics for test 400001-USR21.

The 2000 International 4700 single-unit, flatbed truck, shown in figures 3 and 4, was used for the crash test. Test inertia weight of the vehicle was 15,050 lb. The height to the lower edge of the vehicle front bumper was 20.0 inches, and the height to the upper edge of the front bumper was 31.0 inches. Figure 10 in appendix B gives additional dimensions and information on the vehicle. The vehicle was directed into the installation using the cable reverse tow and guidance system, and was released to be free-wheeling and unrestrained just prior to impact.

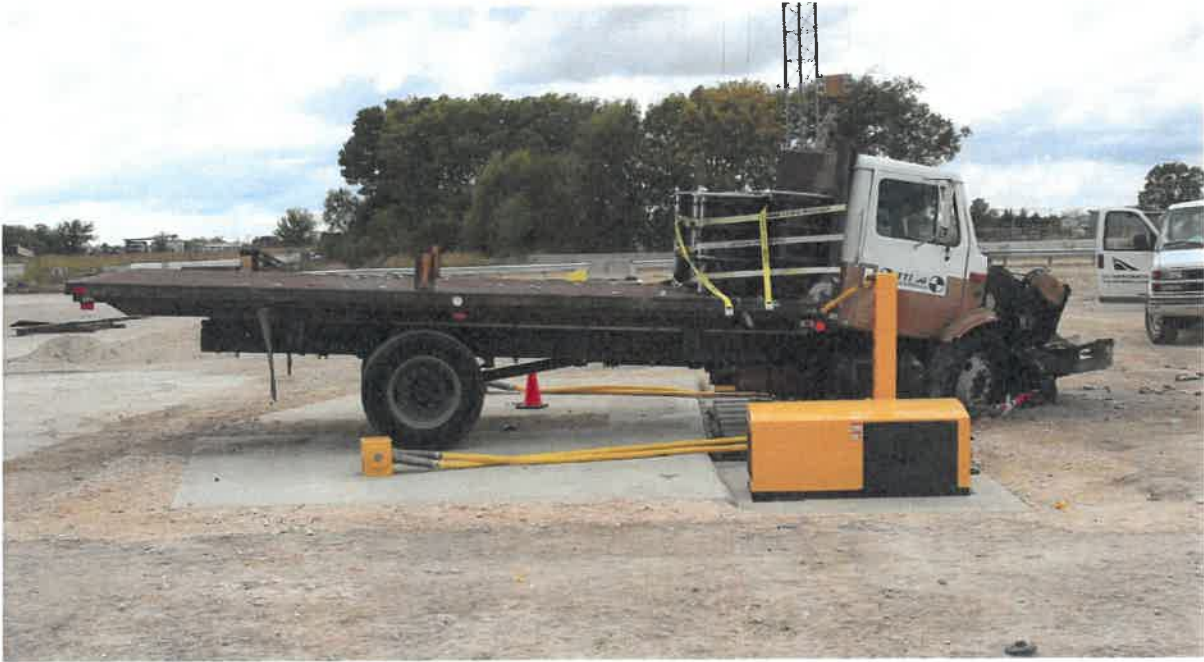
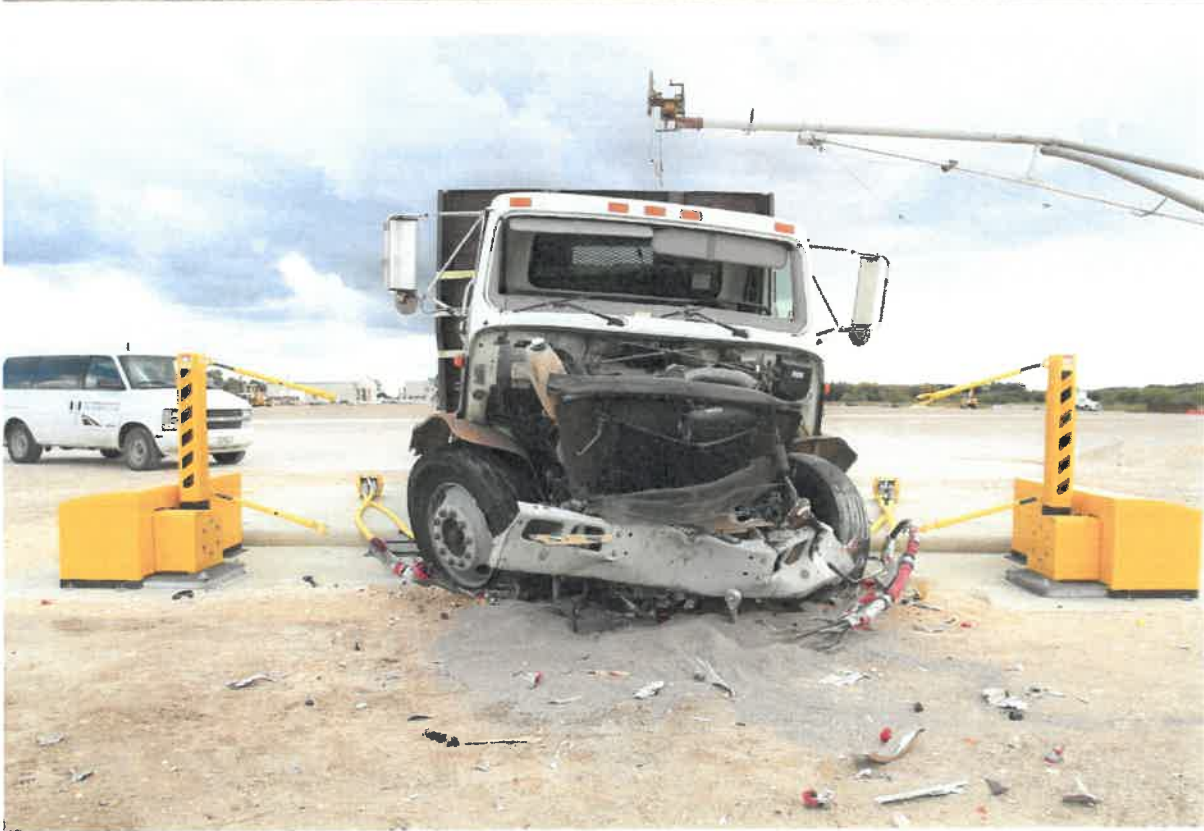
Figure 5. Vehicle position after test 400001-USR21.

Damage to the 12 ft GRAB-400 is shown in figure 5 and 6. The top cable on the left side failed at 96 inches from the connector, and the right side failed at 64 inches from the connector. Isolated strands of the center cable sheared, and the fourth vertical cable from the right side pulled out of the bottom swage.

The 2000 International 4700 single-unit, flatbed truck impacted the 12 ft GRAB-400 at 89.6 degrees, with the centerline of the vehicle aligned with the centerline of the 12 ft GRAB-400. The acceptable range for impact speed for this M40 test was 38.0-46.9 mi/h, and the actual impact speed was 39.3 mi/h. The 12 ft GRAB-400 brought the vehicle to a complete stop. The cargo remained onboard the vehicle; however, the hood of the vehicle was thrown beyond the inside edge of the 12 ft GRAB-400. The leading edge of the cargo bed penetrated 1.1 ft beyond the “inside” edge of the security device.

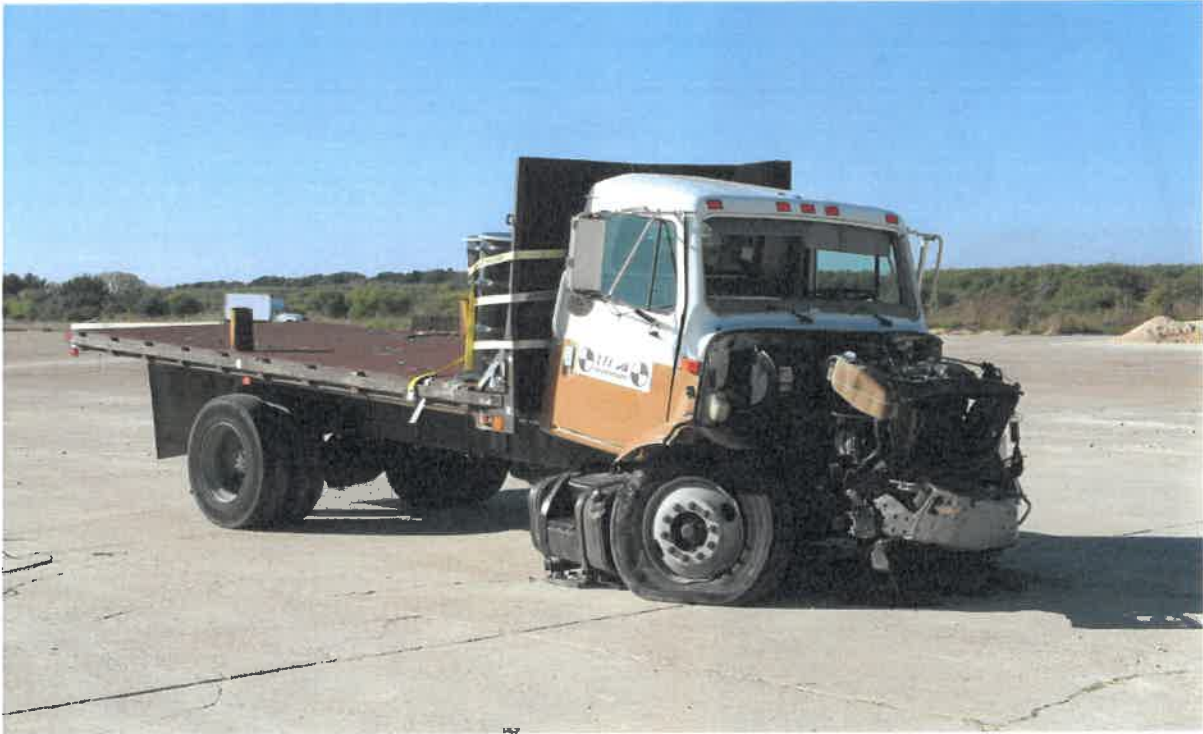
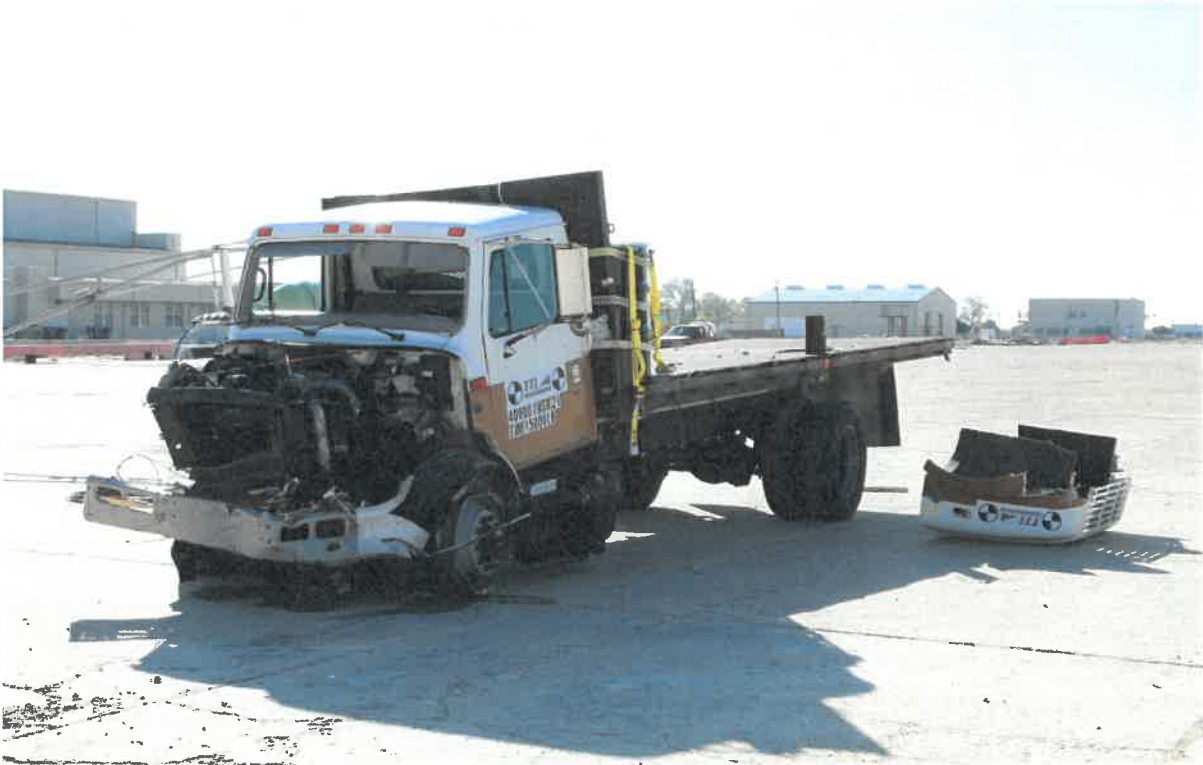
Figure 7. Vehicle after test 400001-USR21.

Damage to the 2000 International 4700 single-unit, flatbed truck is shown in figure 7. The right and left front frame rails, front U-bolts and springs and left rear U-bolts and springs were damaged. The front bumper, hood, radiator, radiator support, fan, water pump, right and left front tires and wheel rims, right and left fuel tanks and windshield were also damaged. Estimated maximum crush to the exterior of the vehicle was 14 inches. Photographs of the interior of the vehicle are shown in figure 8.

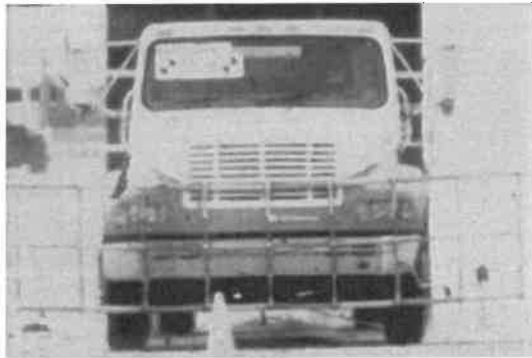
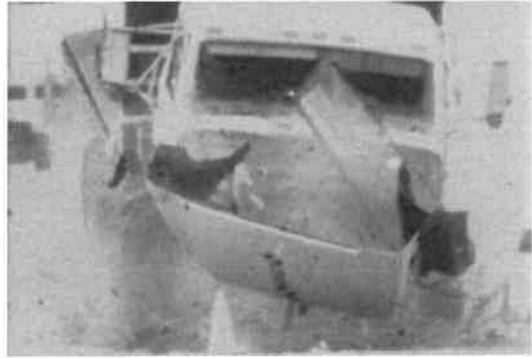
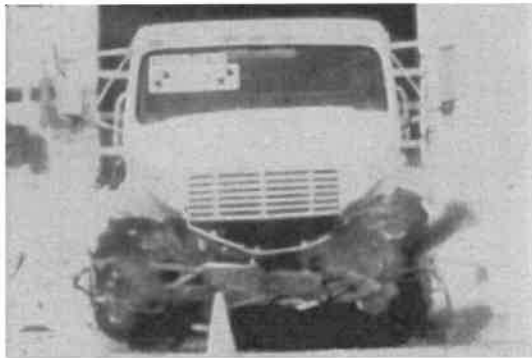
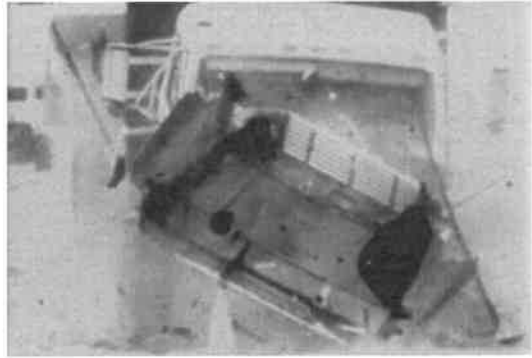
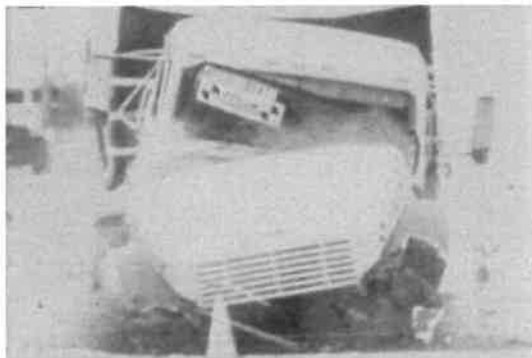
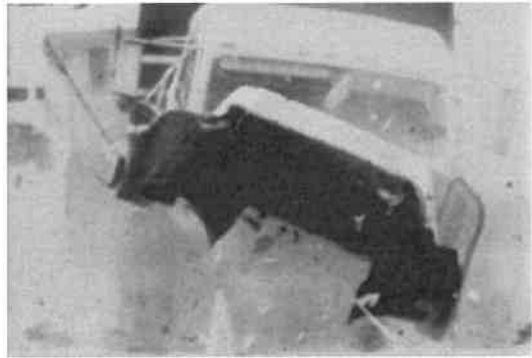
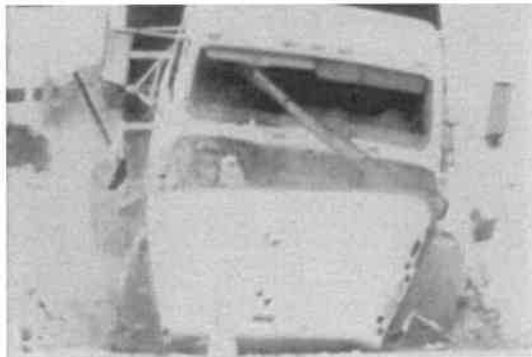
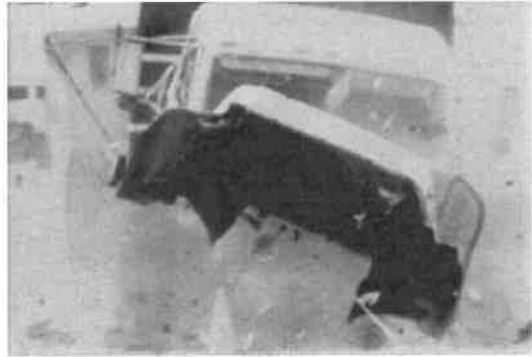
Figure 11. Sequential photographs for test 400001-USR21 (frontal view).

The 2000 International 4700 single-unit, flatbed truck, traveling at an impact speed of 39.3 mi/h, impacted the 12 ft GRAB-400 at an impact angle of 89.6 degrees. The centerline of the vehicle was aligned with the centerline of the 12 ft GRAB-400. At 0.020 s, the net detached from the left upper arm of the GRAB-400 system, and at 0.022 s, the net detached from the right upper arm of the GRAB-400 system. The net detached from the right lower arm of the GRAB-400 system at 0.029 s, and the net began to wrap around the right front tire at 0.047 s. At 0.058 s, the right front tire steered inward, and at 0.063 s, the net detached from the left lower arm. The net began to wrap around the left front tire at 0.076 s, and the right front tire was pulled off the ground surface at 0.089 s. At 0.090 s, the net was pulled downward off the hood and the hood detached from the vehicle, and at 0.116 s, the right front wheel touched the ground surface again. The left front tire aired out at 0.120 s, and the rear wheels became airborne at 0.121 s. At 0.133 s, the net was at maximum deflection of 4.9 ft. Maximum penetration of the front of the cargo bed was 1.1 ft beyond the “inside” edge of the net. Forward motion of the test vehicle stopped at 0.620 s. At 0.932 s, the rear tires touched ground and the vehicle came to rest with the front of the cargo bed 1.0 ft beyond the “inside” edge of the net. Appendix C, figures 11 and 12, show sequential photographs of the test period.

Photographic coverage of the test included three high-speed cameras: one overhead with a field of view perpendicular to the ground and directly over the impact point; one placed behind the installation at an angle; and a third placed to have a field of view parallel to and aligned with the installation at the downstream end. A flashbulb activated by pressure-sensitive tape switches was positioned on the impacting vehicle to indicate the instant of contact with the installation and was visible from each camera. The films from these high-speed cameras were analyzed on a computer-linked motion analyzer to observe phenomena occurring during the collision and to obtain time-event, displacement, and angular data. A mini-DV and still cameras recorded and documented conditions of the test vehicle and installation before and after the test.

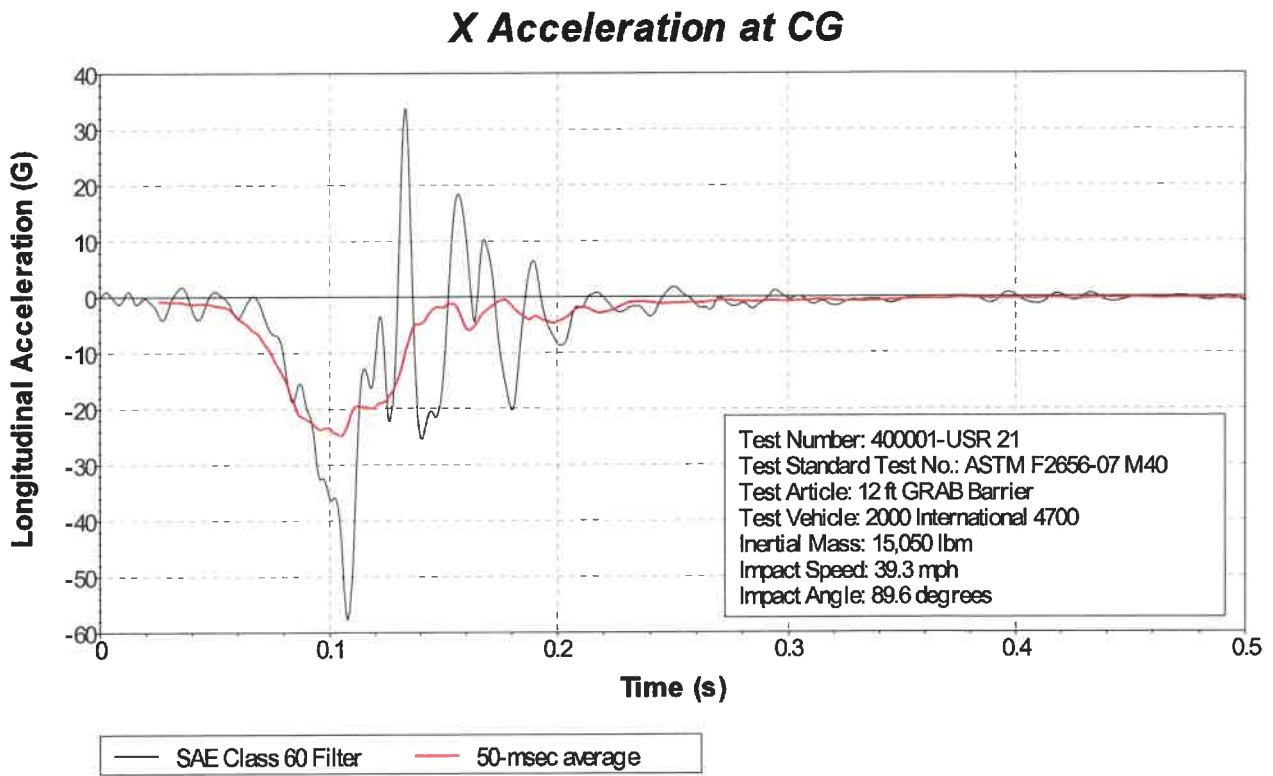
Figure 13. Vehicle longitudinal accelerometer trace for test 400001-USR21 (accelerometer located at center of gravity).

Data from the accelerometer, located at the vehicle center of gravity, were digitized for evaluation of occupant risk for informational purposes only. In the longitudinal direction, the occupant impact velocity was 44.9 ft/s at 0.146 s, the highest 0.010-s occupant ridedown acceleration was 15.2 Gs from 0.174 to 0.184 s, and the maximum 0.050-s average acceleration was -24.8 Gs between 0.080 and 0.130 s. In the lateral direction, the occupant impact velocity was 1.3 ft/s at 0.146 s, the highest 0.010-s occupant ridedown acceleration was 3.8 Gs from 0.147 to 0.157 s, and the maximum 0.050-s average was 1.5 Gs between 0.930 and 0.980 s. These data and other pertinent information from the test are summarized in figure 9. Vehicle accelerations versus time traces are presented in appendix D, figures 13 through 17.

The test vehicle was instrumented with a triaxial accelerometer near the vehicle center of gravity (c.g.) to measure longitudinal, lateral, and vertical acceleration levels; and a backup triaxial accelerometer in the rear of the vehicle to measure longitudinal, lateral, and vertical acceleration levels. These accelerometers were ENDEVCO[®] Model 2262CA, piezoresistive accelerometers with a ± 100 g range.
