Test Report - Commercial in Confidence V0301-V0304 Marshalls Steel Cores

Test Laboratory	HORIBA MIRA Ltd
Date of Report	20/06/2018
Client	Marshalls Street Furniture
Date of Test	23/04/2018
Test Number	V0301-V0304
Report Number	1215709-002-02
Test Type	PAS170-1:2017
Number of Pages	25

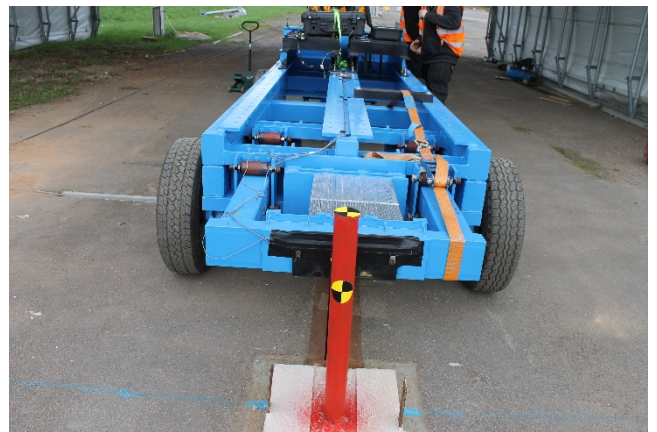
The tested item was mild steel bar, supplied by Marshalls Street Furniture, and cast into a rigid foundation with grade C40 concrete by Wilkinson Environmental.

The test item consisted of 75mm diameter mild steel bar with a height of 800mm above ground.

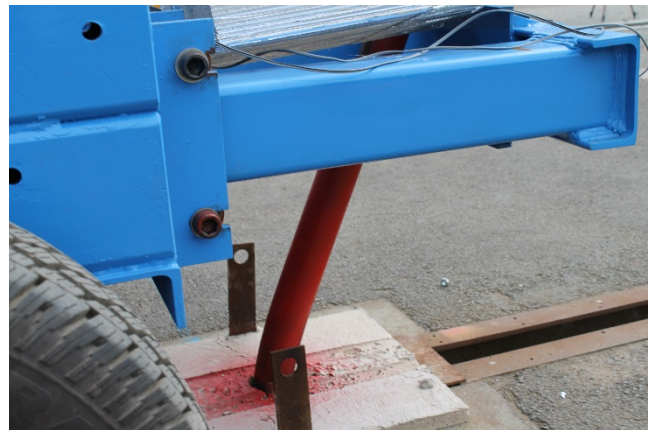
On impact, the bollard deflected rearwards. As deflection reached 28.9° from vertical, the impact trolley began to ride up the test item. The impact trolley bumper then rode over the top of the test item sending the trolley into the air. On returning to ground the honeycomb was ejected from the impact trolley which came to a halt with the rear of the bumper against the rear face of the test item. The bollard then recovered to a static angle of 23.0°. The dynamic penetration was 0.8m, with a static penetration of 0.5m measured.

Peak force calculated from centre of gravity accelerometer was 40.1kN.

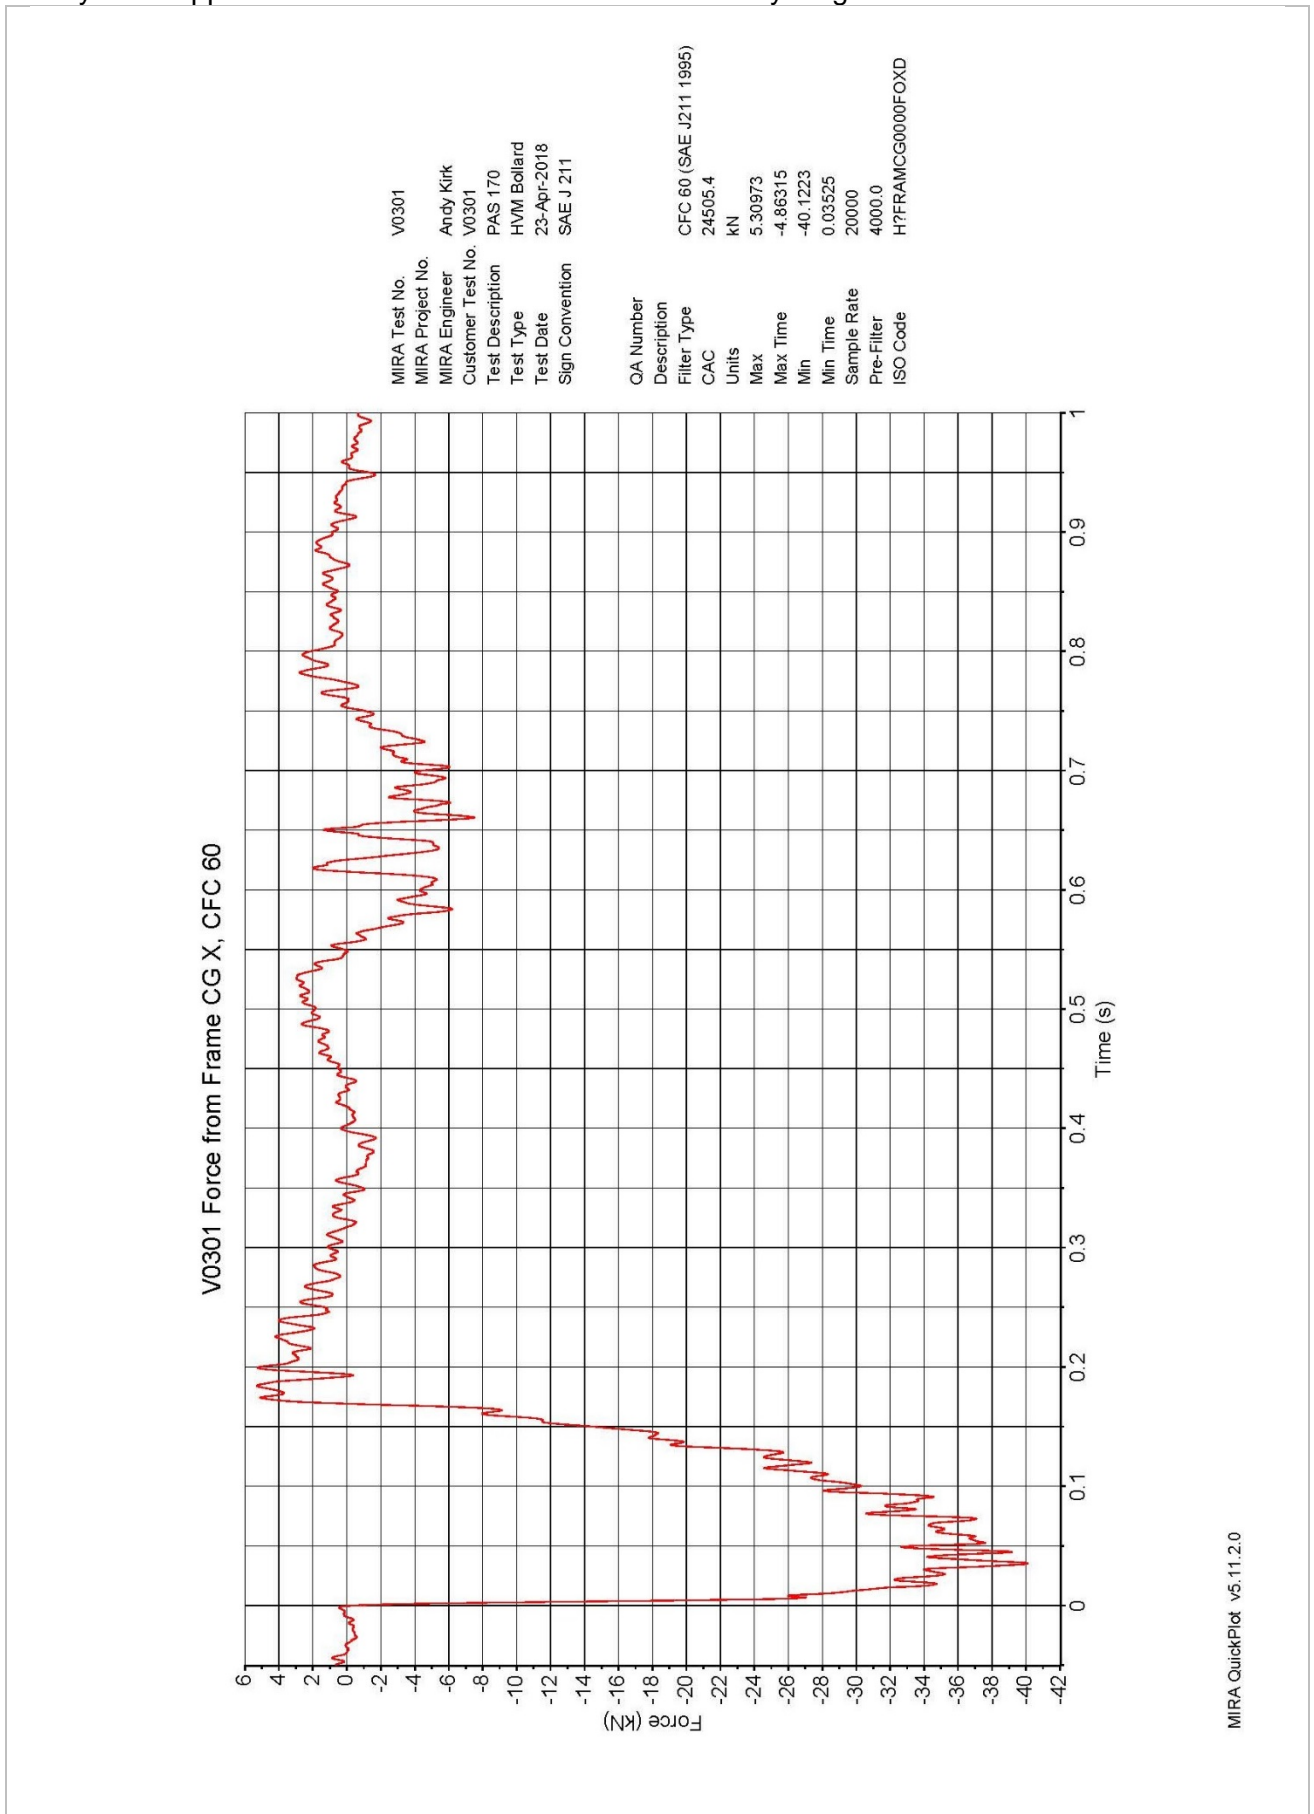
2.2.3 Trolley Force

Trolley force applied is calculated from the Centre of Gravity longitudinal accelerometer data.

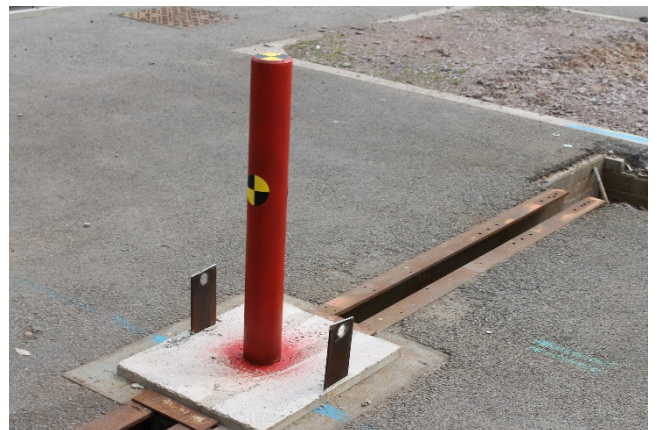
The tested item was fabricated steel bollard, supplied by Marshalls Street Furniture, and cast into a rigid foundation with grade C40 concrete by Wilkinson Environmental.

The test item consisted of an outer core of 101.6mm diameter CHS, 6.3mm wall, welded to an inner core made up four reducing diameter CHS (88.9, 76.1, 60.3 and 48.3), all with 5mm wall, with a height of 800mm above ground.

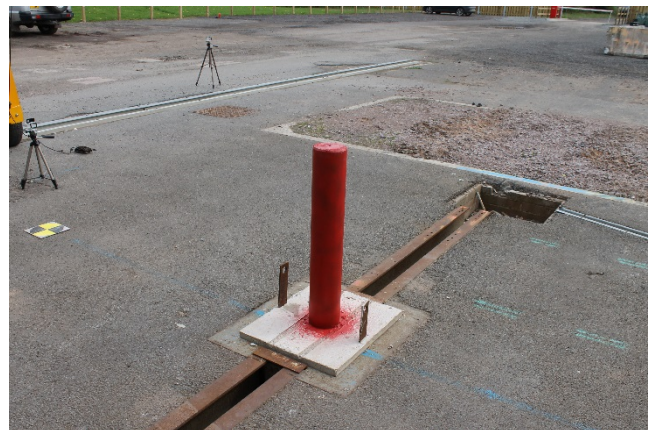
The tested item was fabricated steel bollard, supplied by Marshalls Street Furniture, and cast into a rigid foundation with grade C40 concrete by Wilkinson Environmental.

The test item consisted of an outer core of 139.7mm diameter CHS, 10mm wall, welded to an inner core of 114.3mm diameter CHS with 5mm wall, with a height of 800mm above ground.

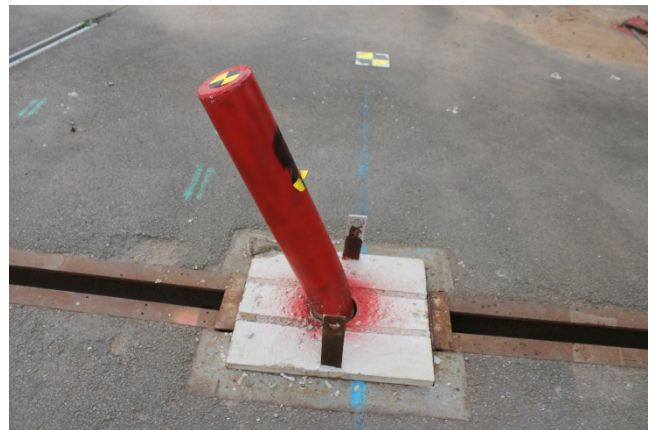
On impact, the tube deflected back to a maximum angle of 25.6° from vertical (longitudinal) then recovered to a static angle of 23.6°. The impact trolley was contained with 0.2m of dynamic penetration.

Peak force calculated from centre of gravity accelerometer was 54.5kN.

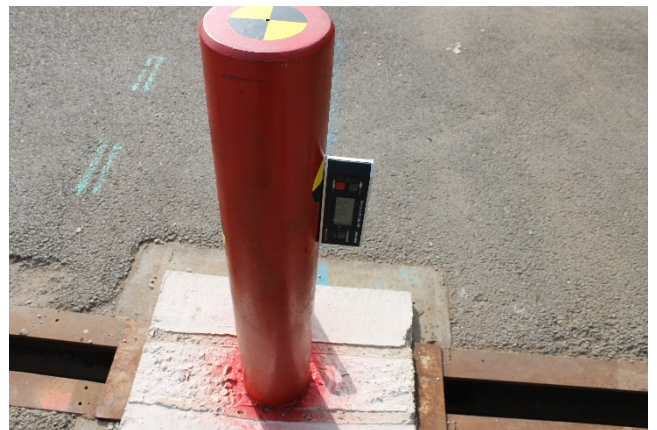
The tested item was fabricated steel bollard, supplied by Marshalls Street Furniture, and cast into a foundation with grade C40 concrete by Wilkinson Environmental.

The test item consisted of an outer core of 139.7mm diameter CHS, 10mm wall, welded to an inner core of 114.3mm diameter CHS with 5mm wall, with a height of 800mm above ground

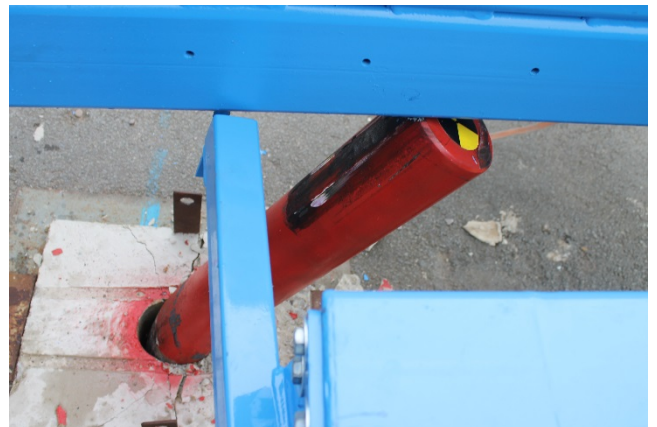
On impact, the test item deflected rearwards. As deflection reached 15.3° from vertical, the impact trolley bumper began to ride up the test item. The test item continued to deflect to 27.3°. The impact trolley bumper lost contact with the top of the test item and the test item rebounded to 24.6°. The impact trolley was deflected upwards before falling down with the trolley chassis contacting the top of the test item causing the test item to further deflect to 25.8°. The impact trolley came to rest on top of the test item. Dynamic penetration was measured at 2.0m and static deflection was measured at 1.8m

Peak force calculated from centre of gravity accelerometer was 183kN.

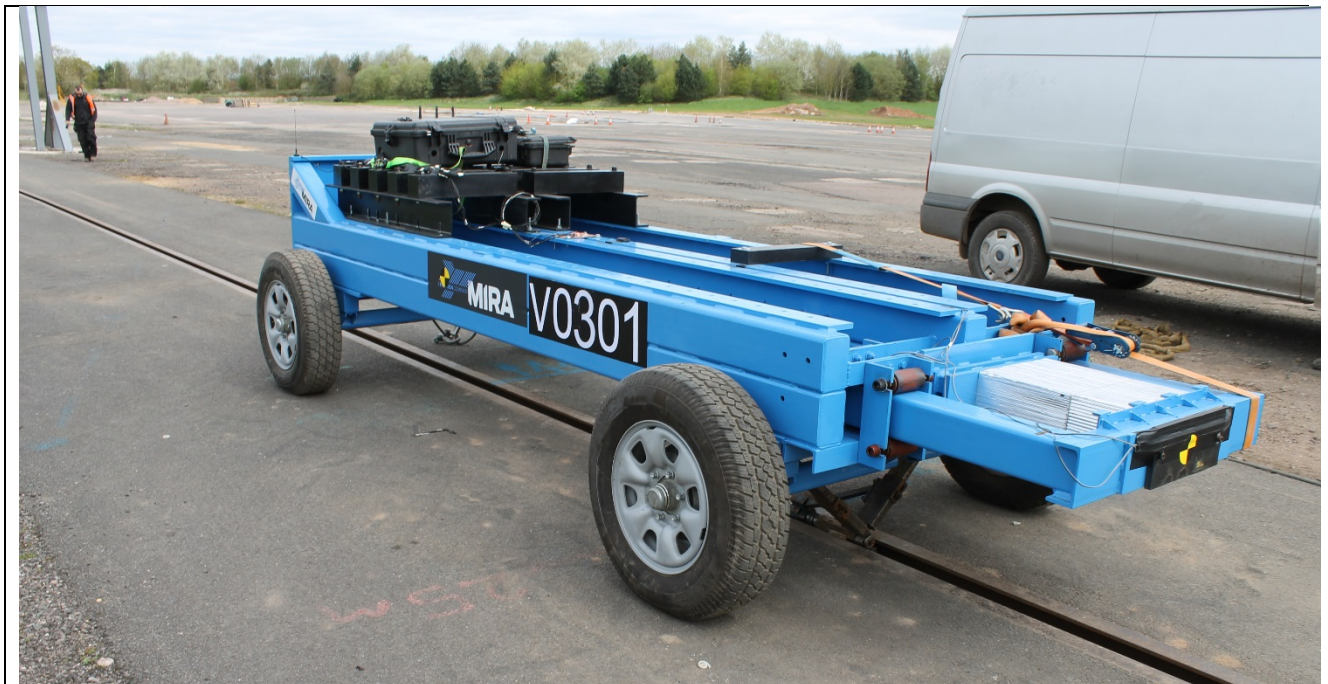
Appendix 1 Impact Trolley Details

Dimension	Specification	Measured
Trolley Manufacturer/supplier	Horiba MIRA designed and built	
A; Vehicle Length (mm)	5000±600	4455
B: Wheelbase (mm)	3000±300	3056
C: Centre of Gravity Horizontal (mm) ^α	1700±100	1747
D: Front Overhang (mm) ^α	1250±200	1056
E: Vertical thickness of impact bumper (mm)	150±25	150
F: Height from lower edge of impact bumper to ground (mm)	525±50	550
G: Tyre Radius (mm)	380±50	340
H: Centre of Gravity Vertical (mm) ^α	720±50	720
I: Chassis Width, outer edges (mm)	1300±50	1295
J: Wheel Track (mm)	1600±50	1600

^α Measured with bumper beam in pre-test condition

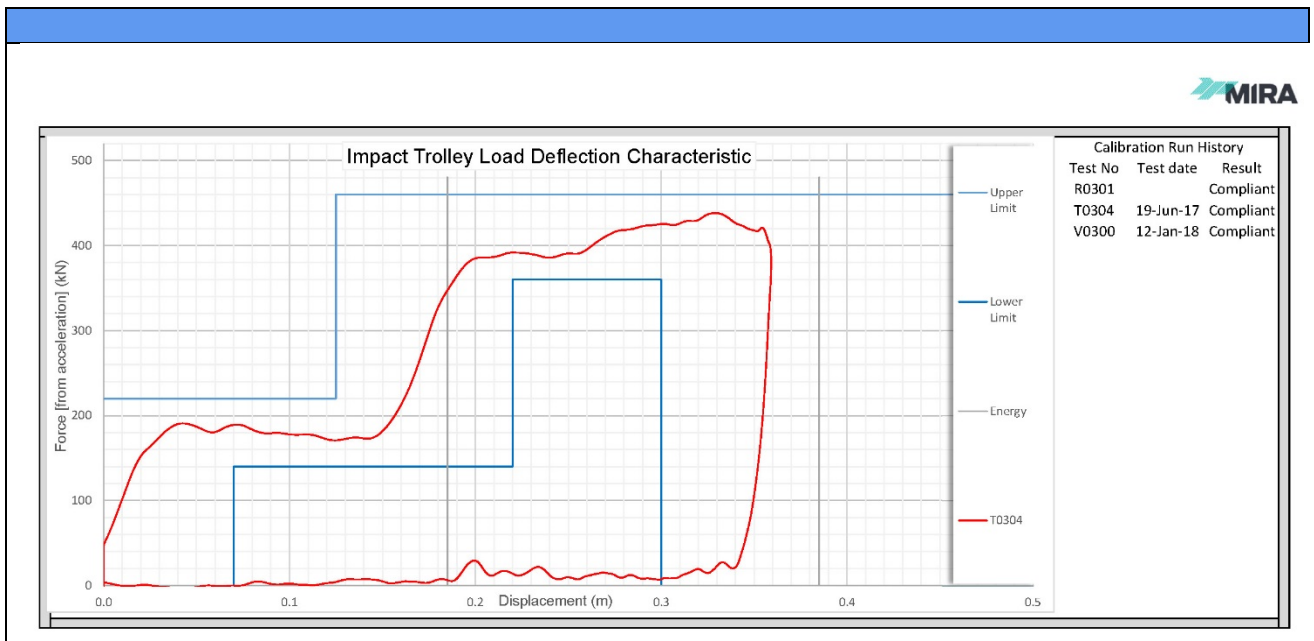
Force Deflection Profile:-

Item	Information / Measurement
Honeycomb Ref:	56MIR13-131355
Calibration Test Impact Speed (km/h):	33.0
Calibration Test Impact Angle (deg):	88.4
Calibration Test Impact Alignment (mm):	54 Right
Calibration Test Impact Height (mm):	565
Test Item Deflection from vertical, longitudinal (°)	2.8 dynamic, 1.2 static
Test Item Deflection from vertical, lateral (°)	0.0
Foundation Deflection from vertical, longitudinal (°)	0..39 dynamic, 0.89 static
Foundation Deflection from vertical, lateral (°)	0.0
