SAFEWOOD DESIGNS BALLISTICS PERFORMANCE TEST REPORT

UL-752, LEVEL 3, BALLISTIC TESTING ON FIBERGLASS CLOTH MIXED WITH RESIN WALL PANEL

K4999.01-119-12 R0

Product Type: 1/2" Fiberglass Cloth Mixed with Resin Wall Panel

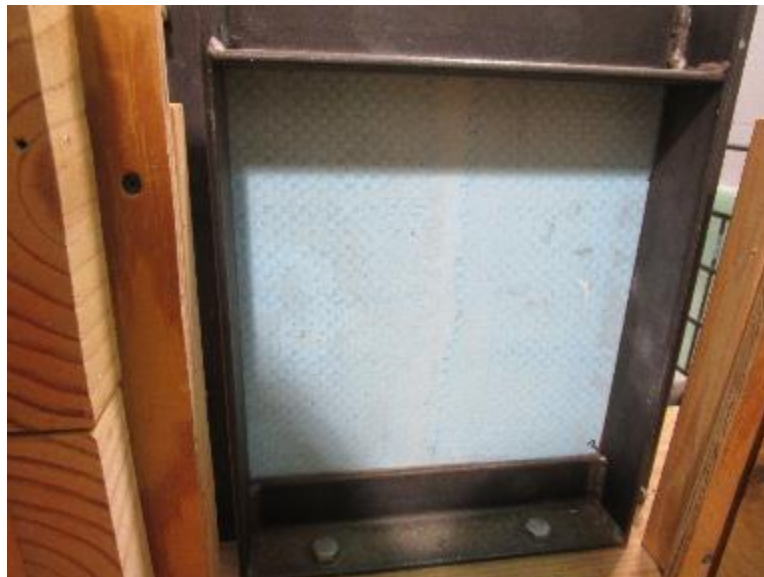
Photo No. 2

Specimen No. 1 (Standard Conditions), Pre-Test Interior

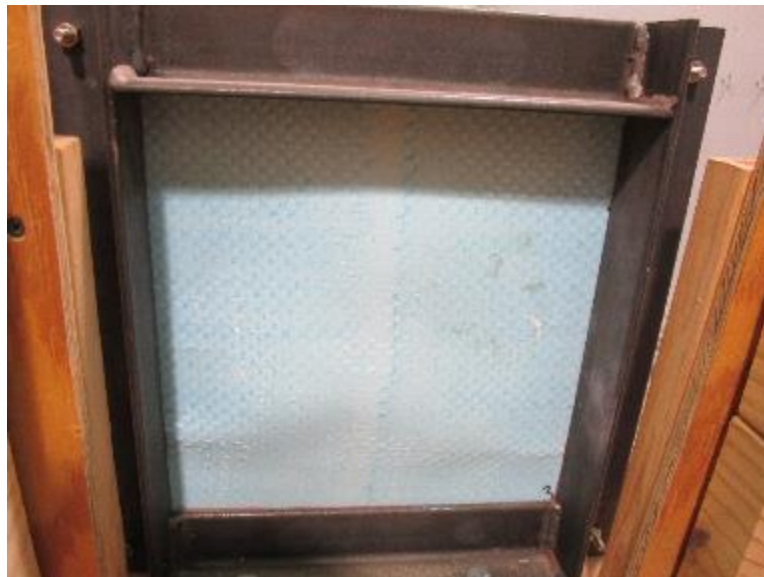
Photo No. 4

Specimen No. 1 (Standard Conditions), Post-Test Interior

SHOT NO.	SHOT LOCATIONS	TEMP. (°F)	VELOCITY (fps)	RESULTS	PASS/FAIL
1	Triangle Pattern (top)	57	1409	No spalling on witness panel	Pass
2	Triangle Pattern (right)	57	1406	No spalling on witness panel	Pass
3	Triangle Pattern (left)	58	1431	No spalling on witness panel	Pass

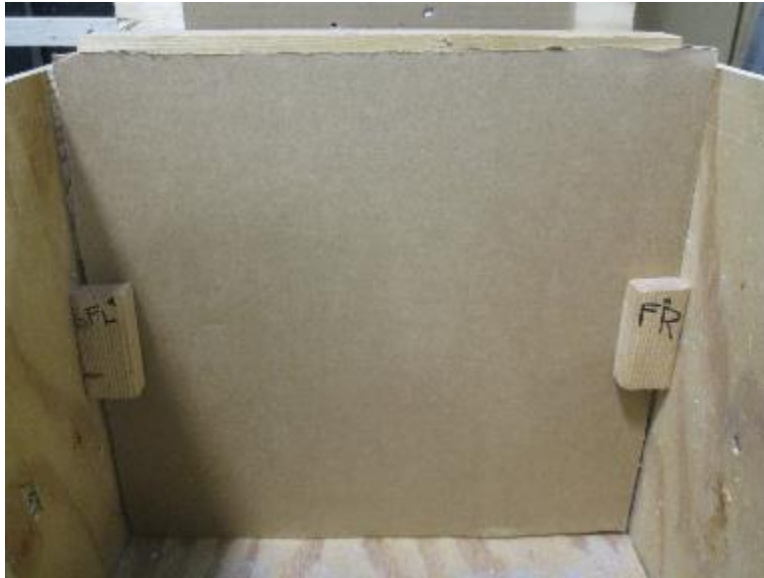
Photo No. 5

Specimen No. 1 (Standard Conditions), Post-Test Witness Panel

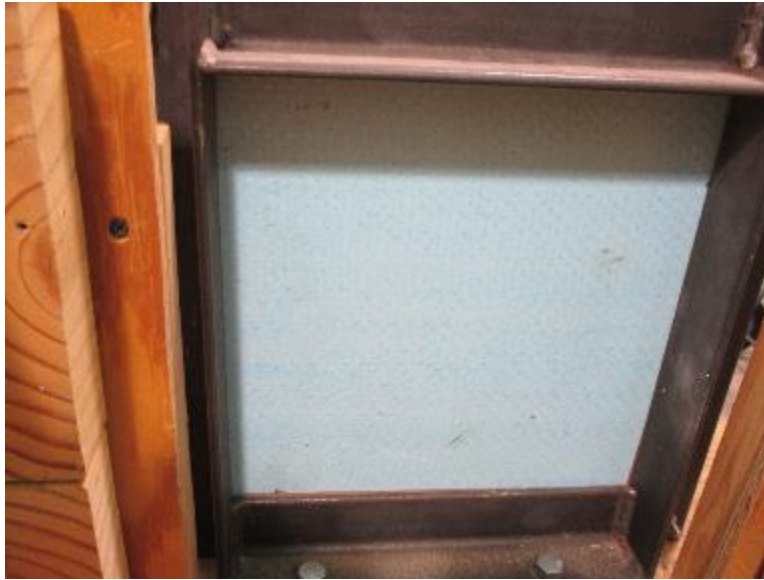
Photo No. 7

Specimen No. 2 (High Temperature Outdoor Use Conditions), Pre-Test Interior

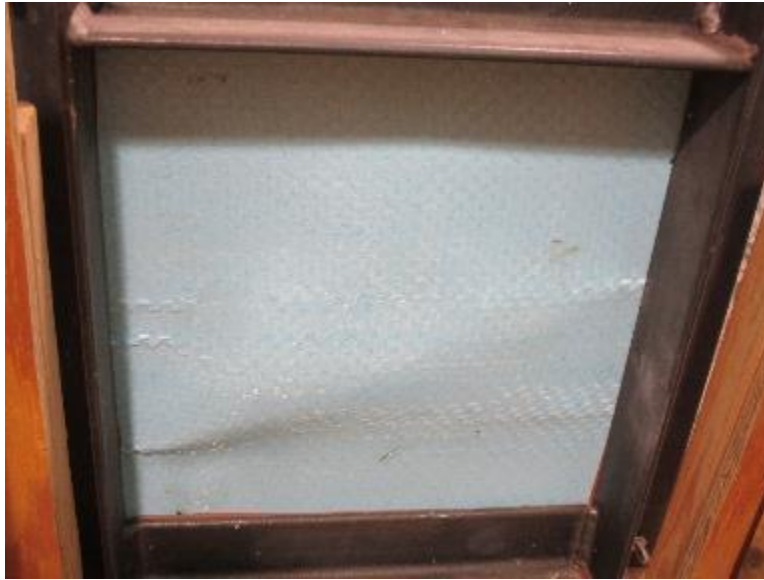
Photo No. 9

Specimen No. 2 (High Temperature Outdoor Use Conditions), Post-Test Interior

SHOT NO.	SHOT LOCATIONS	TEMP. (°F)	VELOCITY (fps)	RESULTS	PASS/FAIL
1	Triangle Pattern (top)	109°F/ 70°F	1410	No spalling on witness panel	Pass
2	Triangle Pattern (right)	103°F/ 70°F	1387	No spalling on witness panel	Pass
3	Triangle Pattern (left)	96°F/ 70°F	1454	No spalling on witness panel	Pass

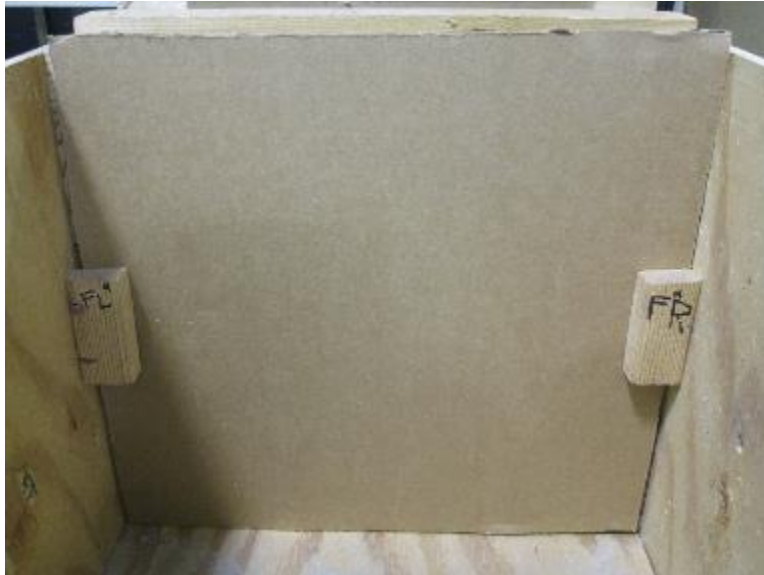
Photo No. 10

Specimen No. 2 (High Temperature Outdoor Use Conditions), Post-Test Witness Panel

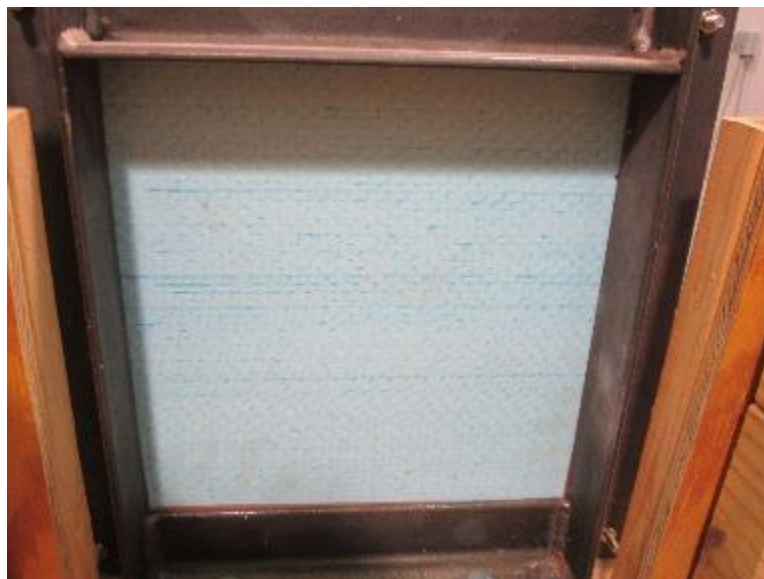
Photo No. 12

Specimen No. 3 (Standard Conditions), Pre-Test Interior

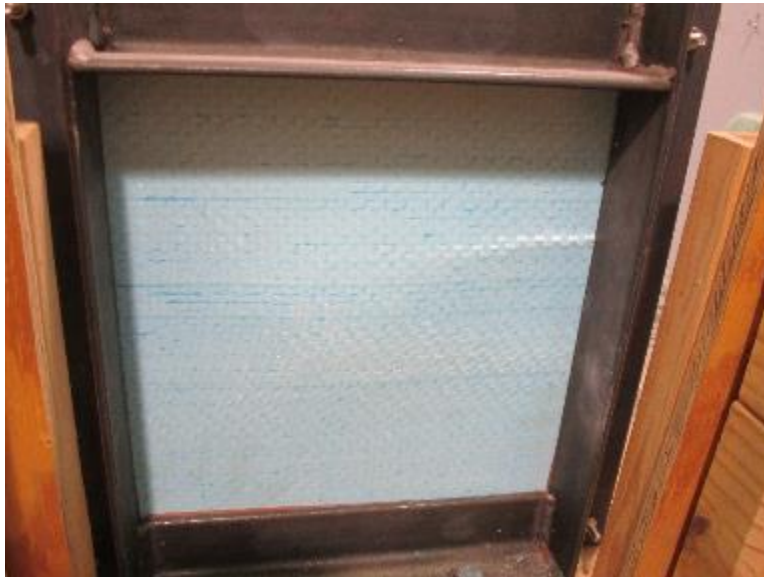
Photo No. 14

Specimen No. 3 (Standard Conditions), Post-Test Interior

SHOT NO.	SHOT LOCATIONS	TEMP. (°F)	VELOCITY (fps)	RESULTS	PASS/FAIL
1	Two Shot Pattern (left)	62	1391	No spalling on witness panel	Pass
2	Two Shot Pattern (right)	63	1378	No spalling on witness panel	Pass

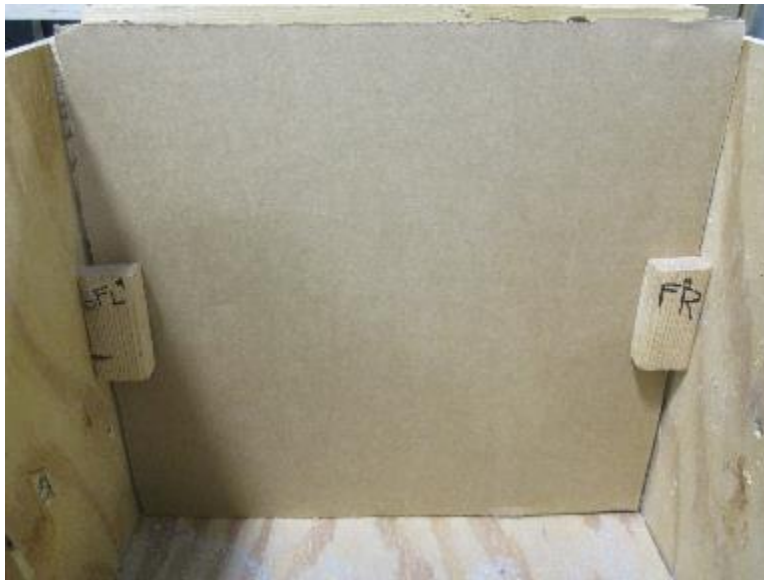
Photo No. 15

Specimen No. 3 (Standard Conditions), Post-Test Witness Panel

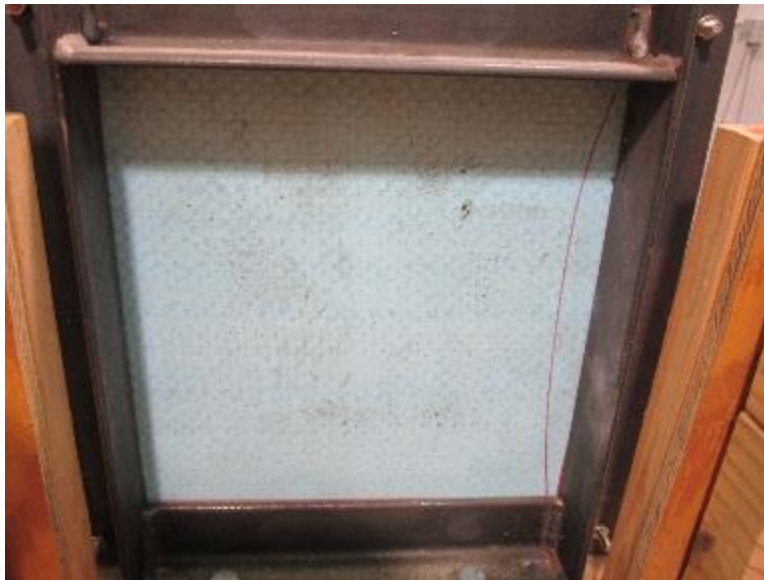
Photo No. 17

Specimen No. 4 (Low Temperature Outdoor Use Conditions), Pre-Test Interior

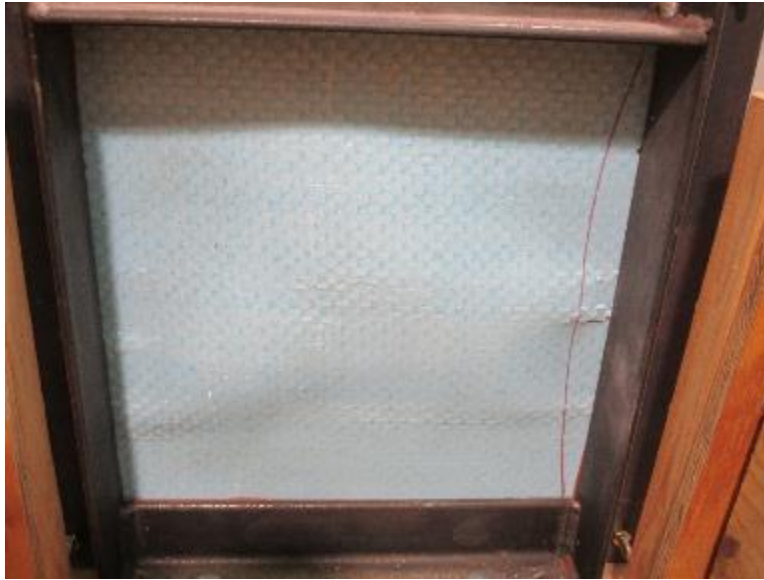
Photo No. 19

Specimen No. 4 (Low Temperature Outdoor Use Conditions), Post-Test Exterior

SHOT NO.	SHOT LOCATIONS	TEMP. (°F)	VELOCITY (fps)	RESULTS	PASS/FAIL
1	Triangle Pattern (top)	43°F/ 64°F	1418	No spalling on witness panel	Pass
2	Triangle Pattern (left)	50°F/ 64°F	1435	No spalling on witness panel	Pass
3	Triangle Pattern (right)	52°F/ 64°F	1424	No spalling on witness panel	Pass

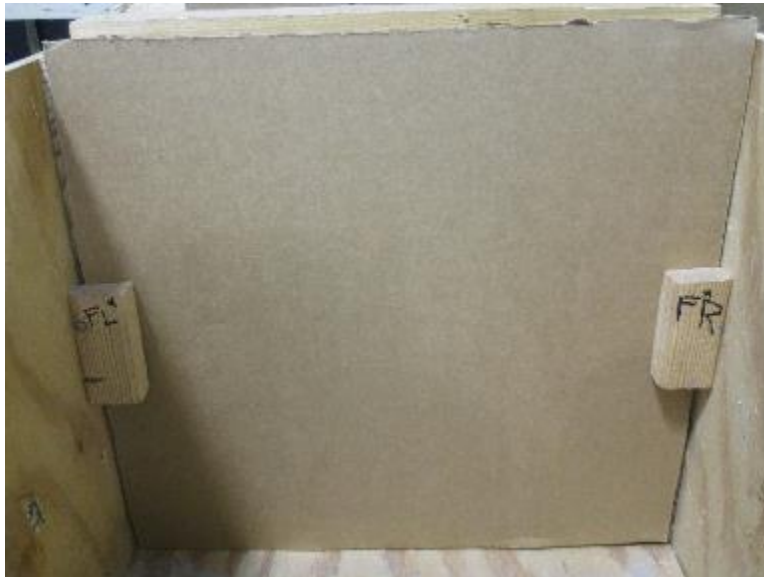
Photo No. 20

Specimen No. 4 (Low Temperature Outdoor Use Conditions), Post-Test Witness Panel
