Test Report - Commercial in Confidence W0017 IWA14-1 2013 N3 Rapid Deployment Barrier

Test Laboratory HORIBA MIRA Ltd
Date of Report 24/04/2019
Client GDTech S.A
Test Item F18 Steel rapid deployment system
Date of Test 26/02/2019
Test Number W0017
Report Number IWA14-1 1219545-002-01
Test Type Vehicle Impact
Product Rating IWA 14-1:2013 Barrier V/7200[N3C]/48/90:29.1
Number of Pages 21

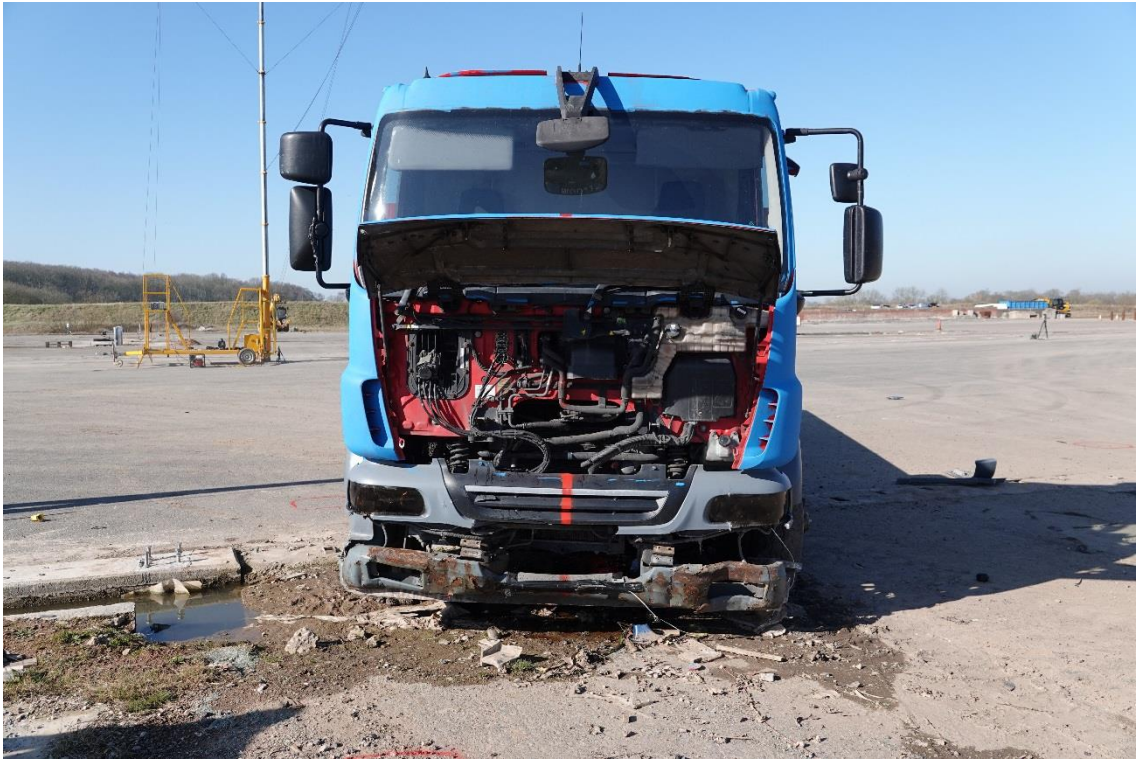
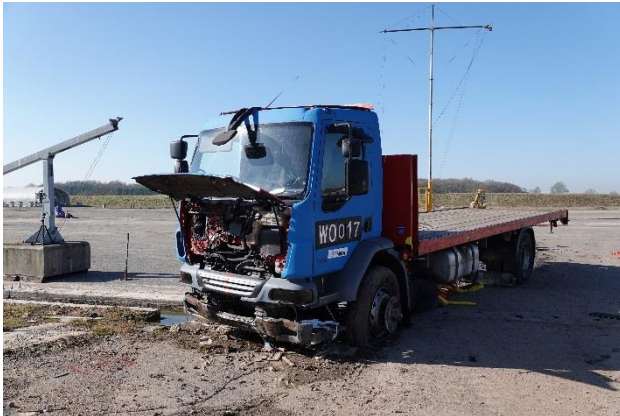
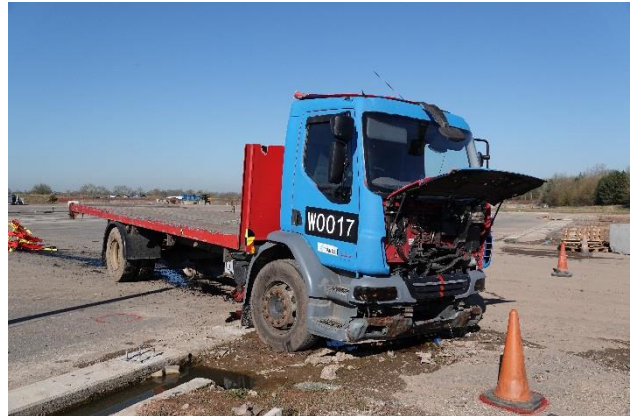
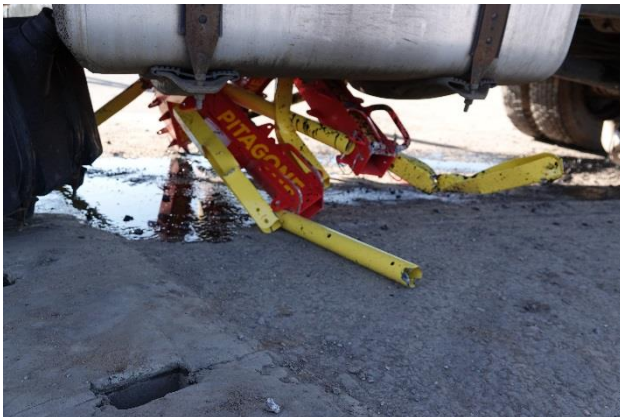
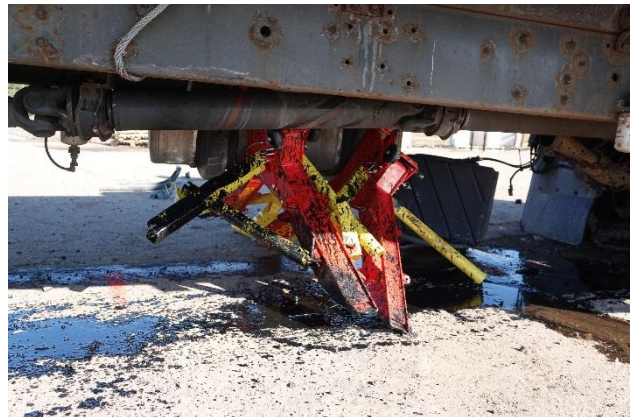
8 Post Impact Product and Vehicle Images

2 units remained trapped under the vehicle, 5 units were attached together 16m into the incident with the link bars twisted and some torn through the drilled pinning points. 1 unit was at 19m forward and 2.5 m to the left of target impact point. All of the units had suffered damage from the impact to varying degrees including all the positioning wheels which were all damaged, rear ground hooks were bent and powder coating damage with some twisting of the main structures.

The front cosmetic panels suffered damage. As did the front bumper. Front driver side tyre was cut. The engine sump was torn open allowing engine oil to be distributed along the floor. The engine was still running and allowed for a follow on attempt which failed due to the 2 units underneath becoming entangled and causing the wheels to loose traction. The centre and rear prop shaft bearings were also damaged along with marking on the prop shaft itself. The Ad-Blue tank was torn from its mountings and the rear exhaust silencer was detached.
