## Test Report - Commercial in Confidence W0017 PAS68 N3 Rapid Deployment Barrier

Test Laboratory	HORIBA MIRA Ltd
Date of Report	24/04/2019
Client	GD Tech S.A
Test Item	F18 Steel rapid deployment system
Date of Test	26/02/2019
Test Number	W0017
Report Number	PAS68 1219545-002-02
Test Type	Vehicle Impact
Product Rating	PAS68:2013 Barrier V/7500(N3)/48/90:28.1/18.0
Number of Pages	20

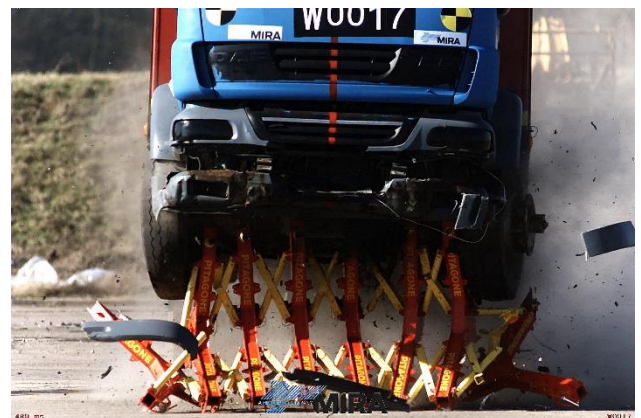
The test vehicle centreline was aligned to the middle of the deployed units. Upon impact the units rotated forward with the rear lower spikes digging into the ground and the units coming into contact with the underside of the vehicle and engine. The front axle lifted off the ground and the units were pushed forward. As the units were pushed they became separated and rotated. The vehicle dropped back down onto the units which then came into contact with the prop shaft causing more damage to the test item and lifting the rear axle from the floor. The vehicle then slowed coming to a halt with 28.1m of penetration.

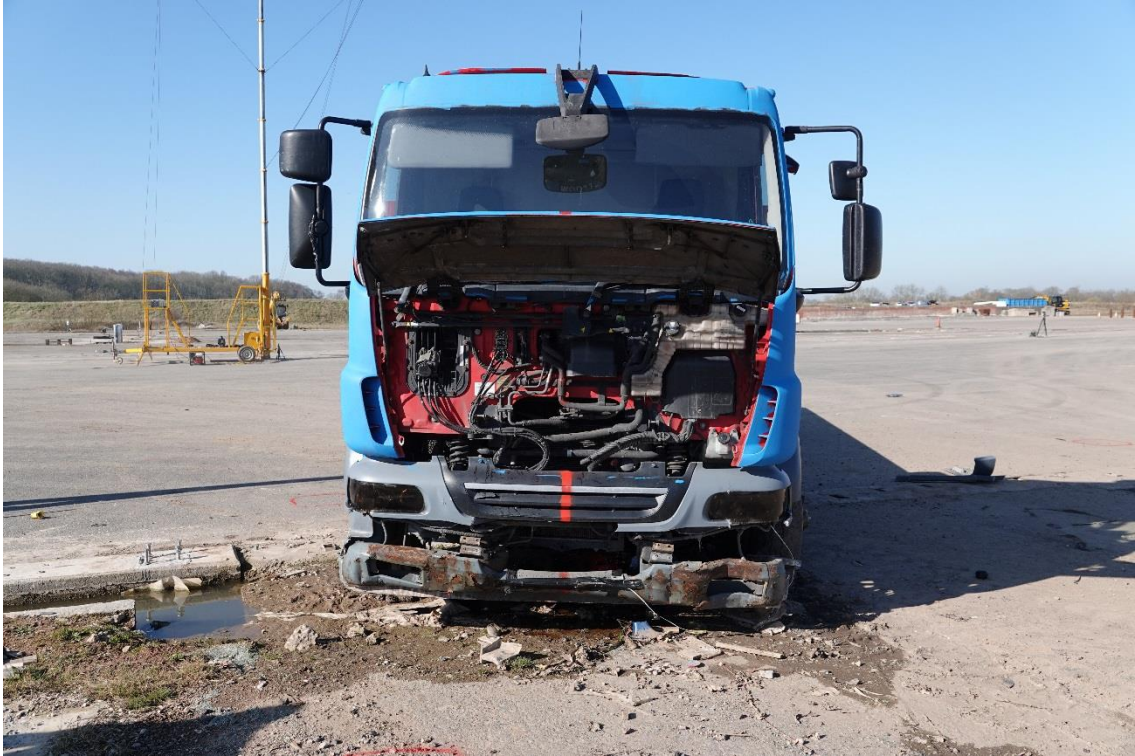
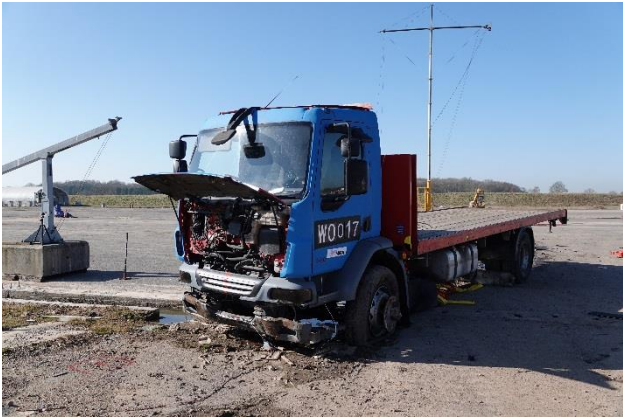
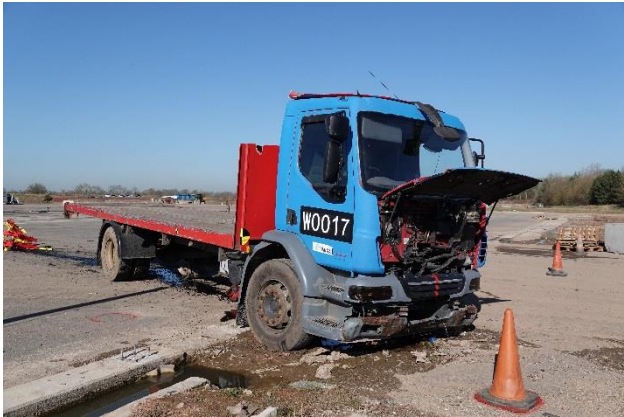
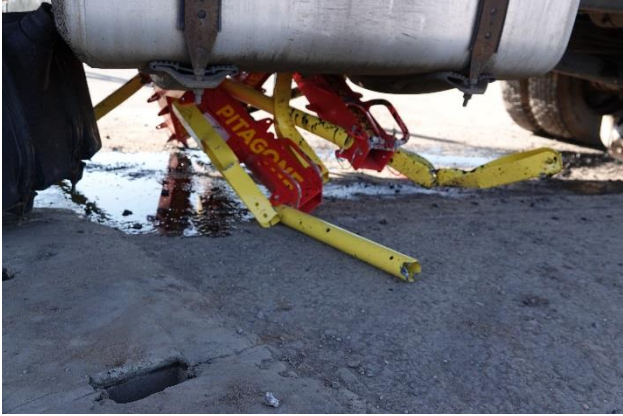
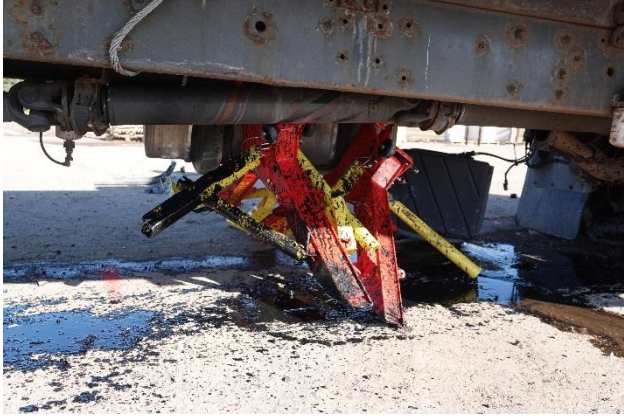
# 8 Post Impact Product and Vehicle Images

2 units remained trapped under the vehicle, 5 units were attached together 16m into the incident with the link bars twisted and some torn through the drilled pinning points. 1 unit was at 18m forward and 2.5 m to the left of target impact point. All of the units had suffered damage from the impact to varying degrees including all the positioning wheels which were all damaged, rear ground hooks were bent and powder coating damage with some twisting of the main structures.

The front cosmetic panels suffered damage. As did the front bumper. Front driver side tyre was cut. The engine sump was torn open allowing engine oil to be distributed along the floor. The engine was still running and allowed for a follow on attempt which failed due to the 2 units underneath becoming entangled and causing the wheels to loose traction. The centre and rear prop shaft bearings were also damaged along with marking on the prop shaft itself. The Ad-Blue tank was torn from its mountings and the rear exhaust silencer was detached.
